# Service Repair Documentation

## Level 2.5 - C65

## Introduction

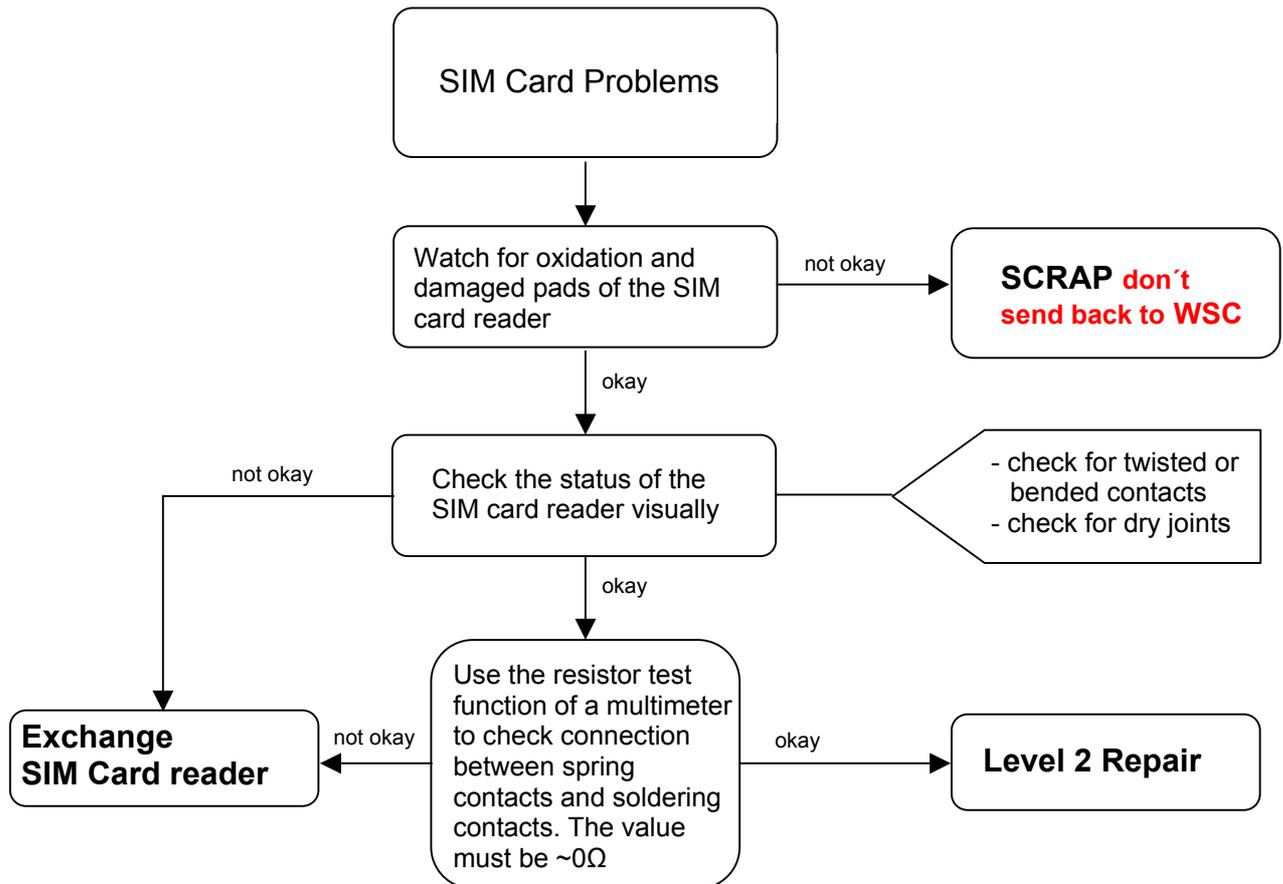
### Connector SIM Card Reader

Fault Symptoms	
Customer: Handset does not accept SIM card	GRT: SIM Card Problems

Use soldering iron to remove defective component. Avoid excessive heat! Watch surrounding components! Resolder new component afterwards.

E-commerce order number: L36334-Z97-C335  
Soldering temperature: 240 - 255°C  
IRIS Diagnose Code: 43300 Interface/SIM Cardreader/Mechanical Damage

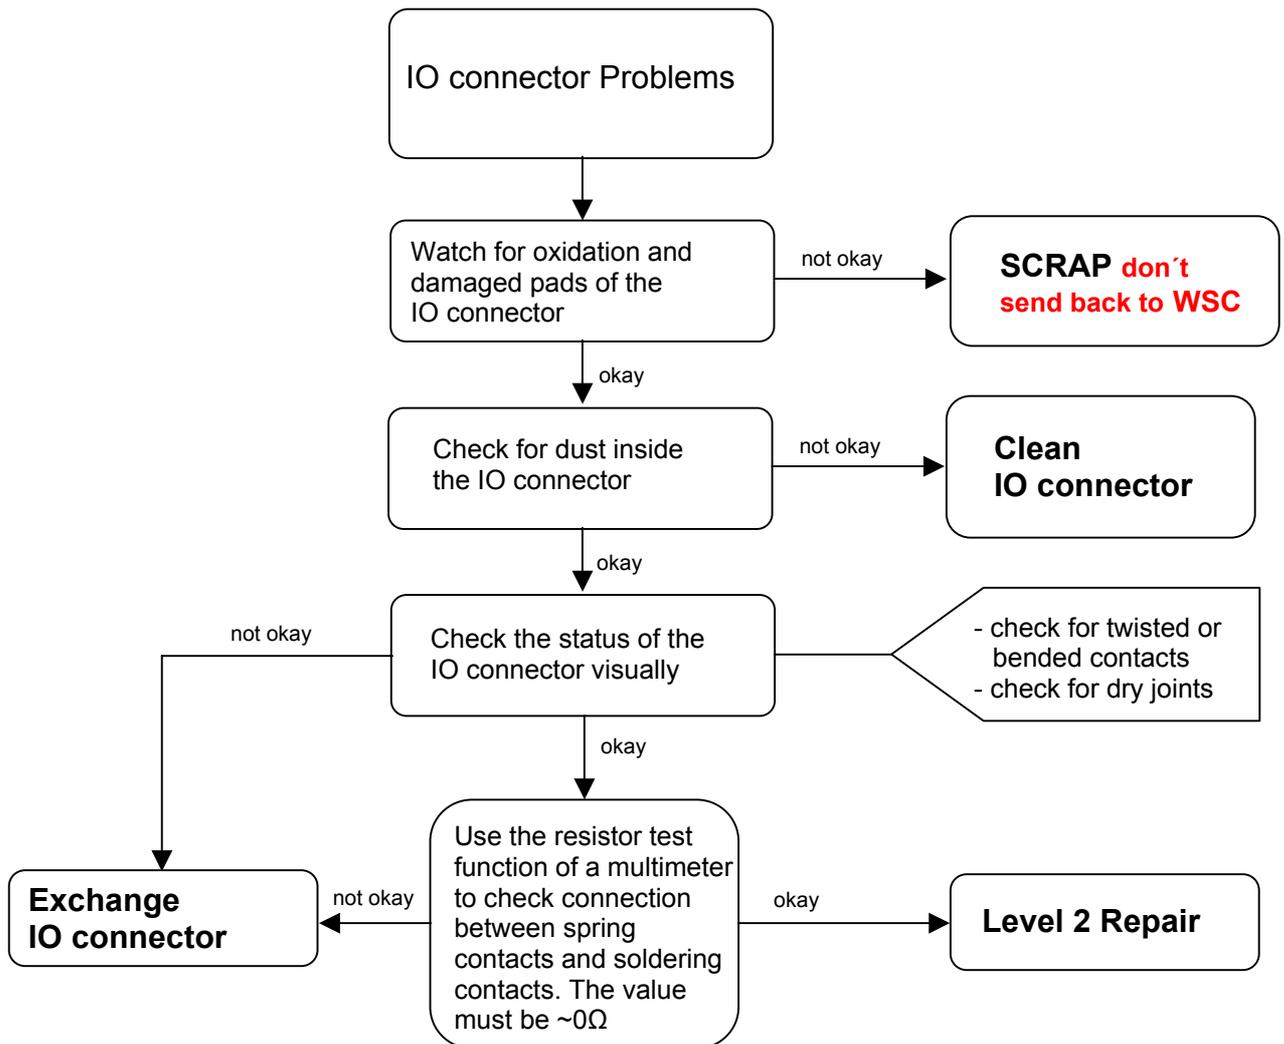
#### Connector IO Jack

Fault Symptoms	
Customer: Charging Problems Problems with external loudspeaker or microphone when using a car kit Problems with accessories connected at the IO connector	GRT: No connection to GRT Tbd.

Use soldering iron to remove defective component. Avoid excessive heat! Watch surrounding components!  
Resolder new component afterwards.

E-commerce order number: L36334-Z93-C303  
Soldering temperature: 240 - 255°C  
IRIS Diagnose Code: 46100 Interface/Charging Connector/Mechanical Damage  
47300 Interface/Data Interface/Mechanical Damage  
4B100 Interface/Headset Connector/Mechanical Damage

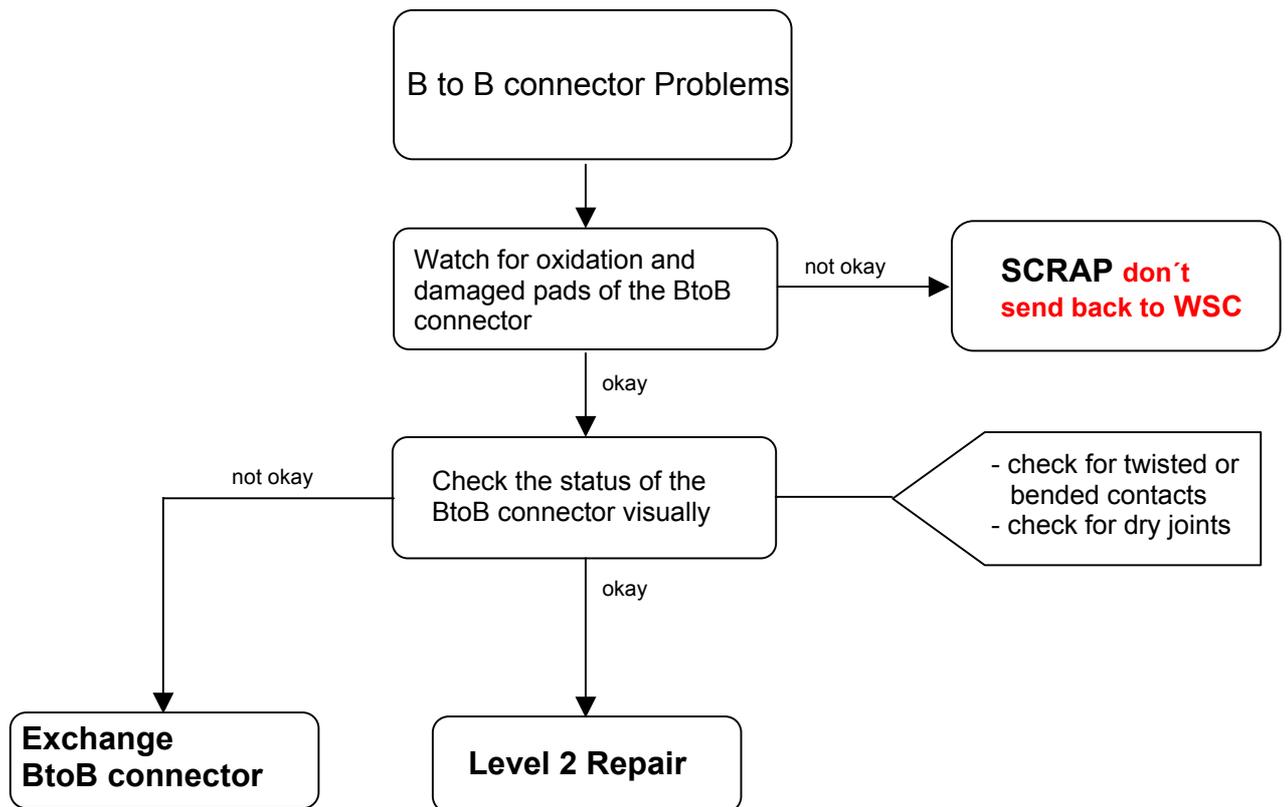
### Connector Board to Board

Fault Symptoms	
Customer: Keyboard malfunction Keypad illumination does not work	GRT: Keyboard malfunction Tbd.

Use hot air blower to remove defective component. Avoid excessive heat! Watch surrounding components!  
 Resolder new component afterwards.

E-commerce order number: L36334-Z97-C162  
 Soldering temperature: 240 - 255°C  
 IRIS Diagnose Code: 32100 Keys / Main / No Function  
 32200 Keys / Main / Reduced Functionality  
 36000 Keys / Illumination

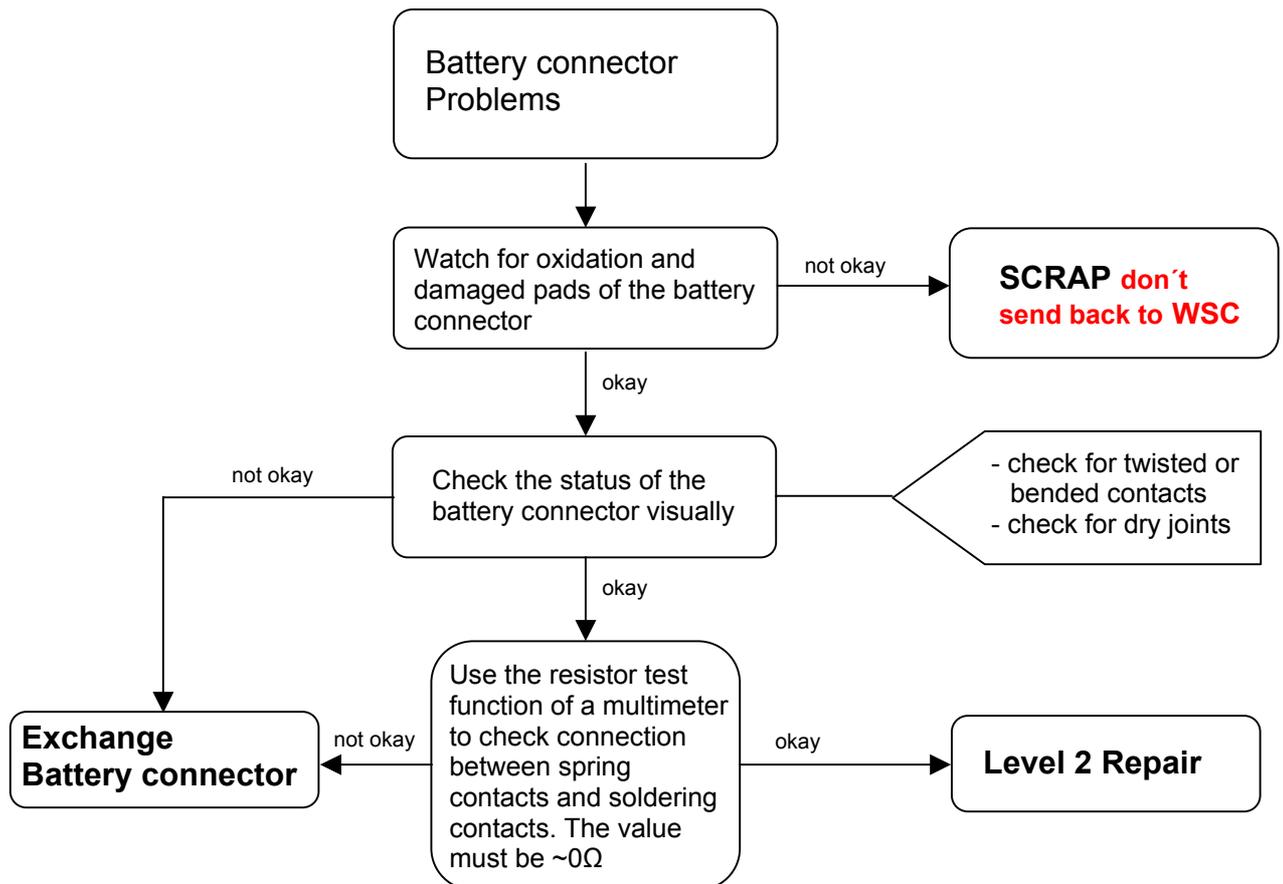
### Connector BATTERY

Fault Symptoms	
Customer: Mobile does not switch on	GRT: No connection to GRT

Use hot air blower to remove defective component. Avoid excessive heat! Watch surrounding components! Resolder new component afterwards.

E-commerce order number: L36334-Z97-C336  
Soldering temperature: 240 - 255°C  
IRIS Diagnose Code: 13000 Battery/Mechanical Damage

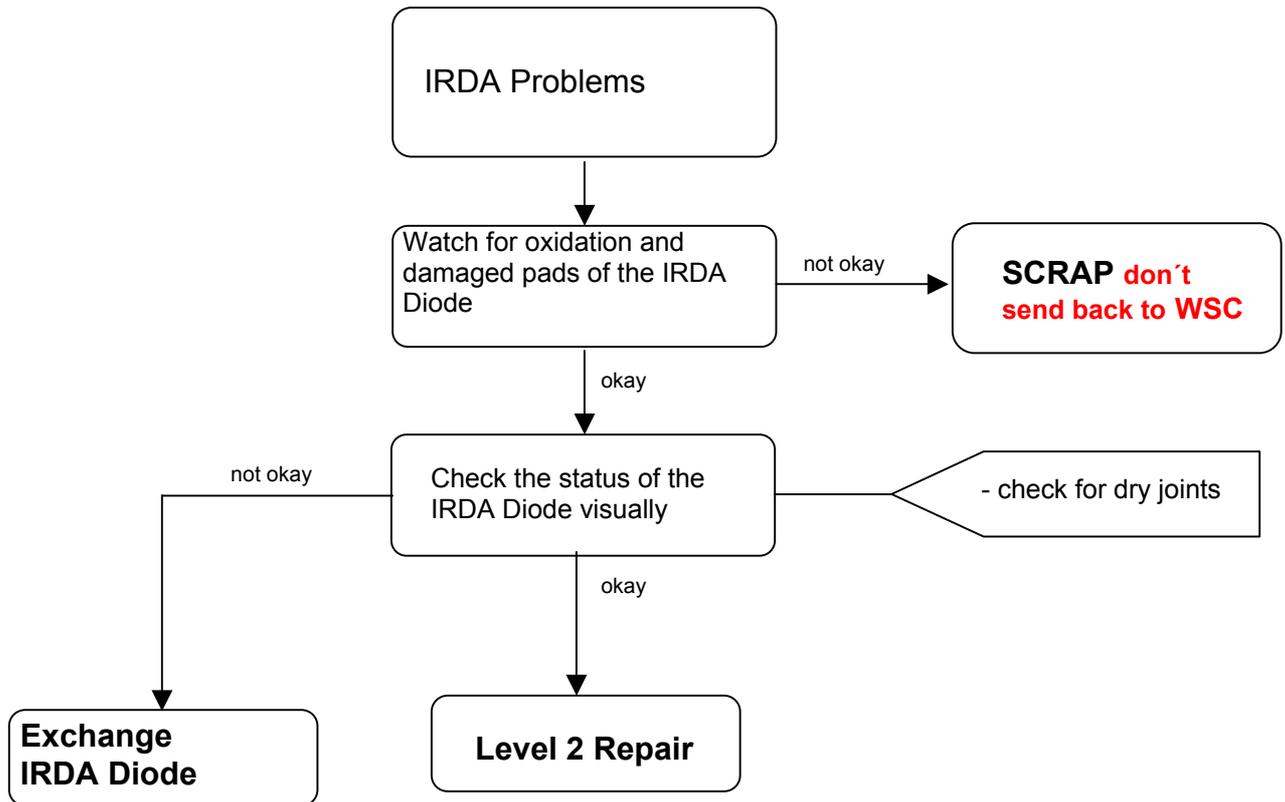
### Irda Diode

Fault Symptoms	
Customer: IRDA does not work	GRT: Tbd.

Use hot air blower to remove defective component. Avoid excessive heat! Watch surrounding components! Resolder new component afterwards.

E-commerce order number: L36197-F5008-F492  
 Soldering temperature: 240 - 255°C  
 IRIS Diagnose Code: 41100 Interfaces / IRDA / No Function  
 41300 Interfaces / IRDA / Mechanical Damage

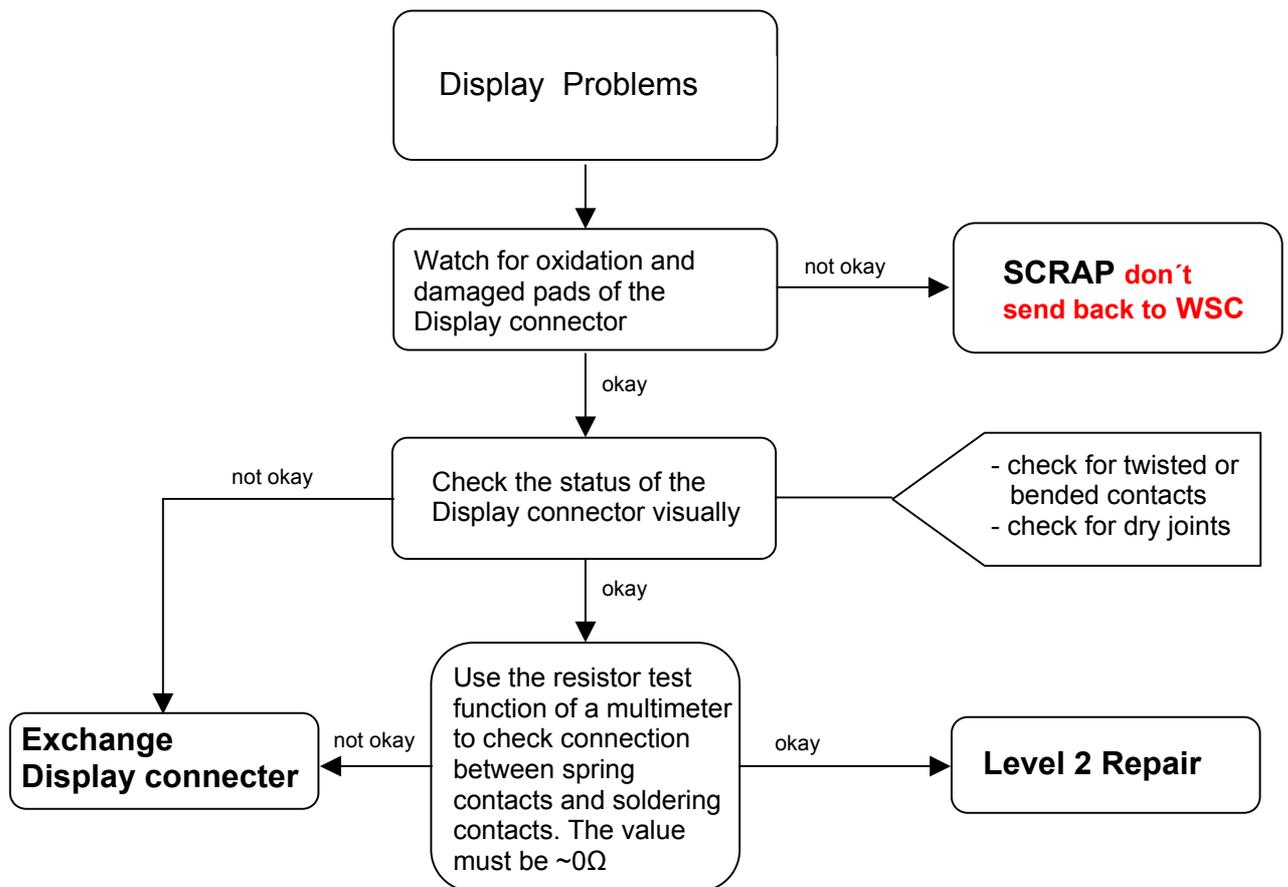
### Connector Display

Fault Symptoms	
Customer: Display problems, like missing lines or columns on the LCD or display contrast problems or illumination problems	GRT: Display Problems

Use soldering iron to remove defective component. Avoid excessive heat! Watch surrounding components! Resolder new component afterwards.

E-commerce order number: L36334-Z97-C205  
Soldering temperature: 240 - 255°C  
IRIS Diagnose Code: 21000 Display / Performance  
22000 Display / Background Illumination
