Service Repair Documentation Level 3 (2.5 light) – S75

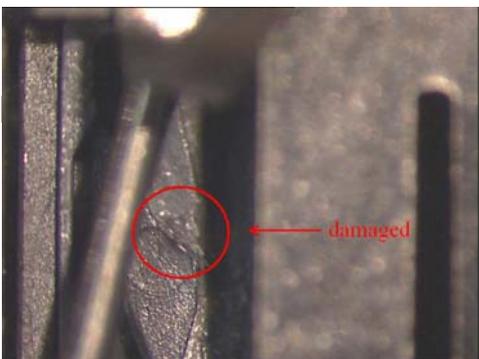
Lock mechanism damaged
