Service Repair Documentation

Level 2.5 light – CX75, M75

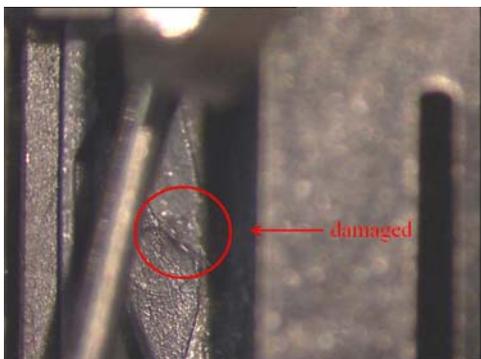
The MMC Reader is located on the opposite of the SLIM-Lumberg connector. Therefore the risk to damage the plastic material of this MMC-Reader is potentially high if excessive heat is used while removal or soldering of the SLIM-Lumberg connector.

Lock mechanism damaged

- a) Remove the SLIM-Lumberg connector with a soldering iron and Desolder Wick
- b) Clean the Pads afterwards
- c) Solder the new connector by using soldering iron under consideration of the max. allowed temperature range.

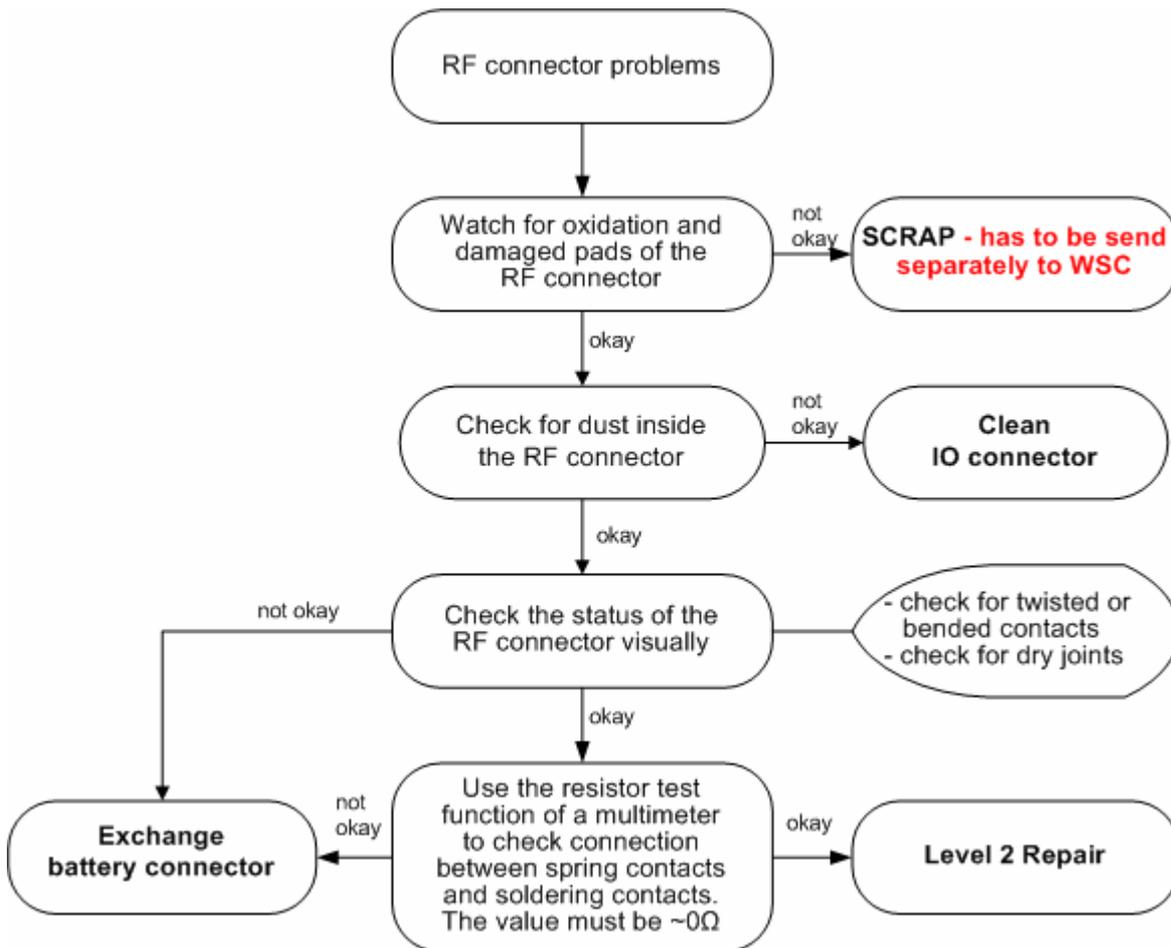
Connector RF

Fault Symptoms	
Customer: Network search No location update possible	GRT: Failure by TX/RX measurements No location update possible

Use hot air blower to remove defective component. Avoid excessive heat! Watch surrounding components! Resolder new component afterwards.

E-commerce order number: L36334-Z93-C297
 E-commerce order name: CONNECTOR ANTENNA 6mm
 Soldering temperature: ~ 360°C TIP Temp.
 IRIS Diagnose Code:
 81100 Radio / No Contact / Int. Antenna
 82100 Radio / Low Receiving Signal / Int. Antenna
 83100 Radio / Dropped Calls / Int. Antenna
 84100 Radio / Call Setup / Int. Antenna

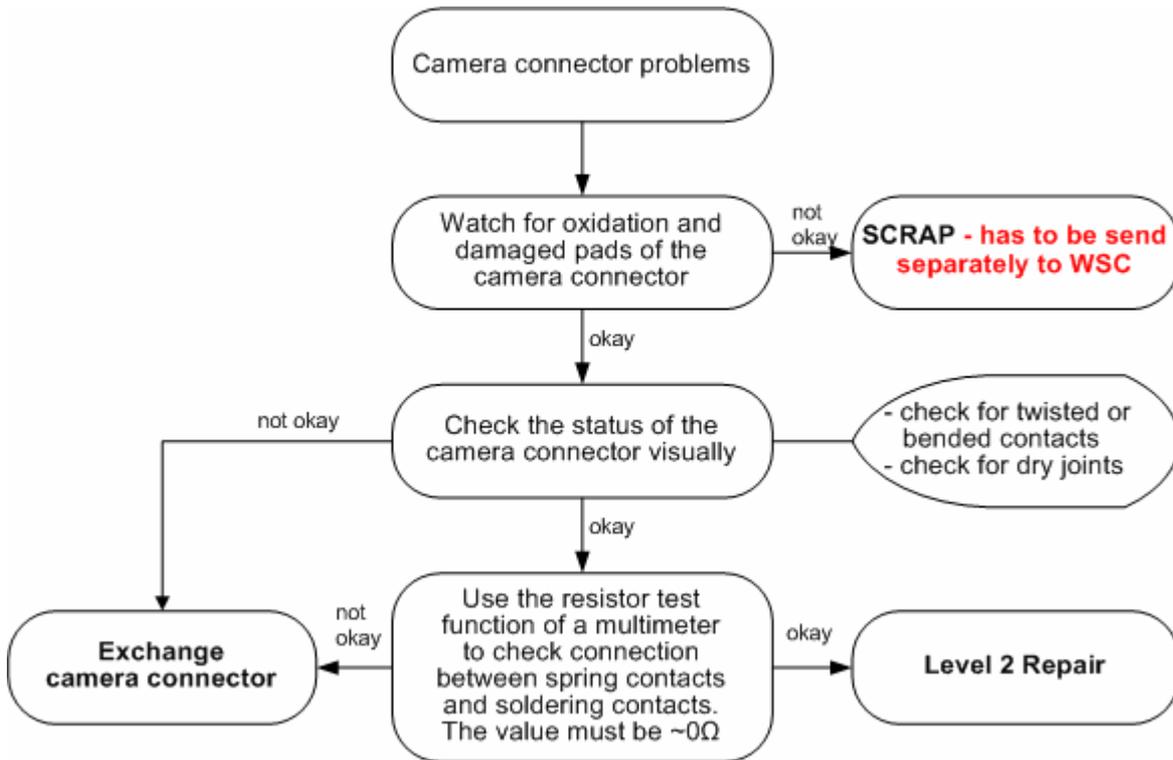
Connector CAMERA

Fault Symptoms	
Customer: Camera malfunction	GRT: Tbd.

Use hot air blower to remove defective component. Avoid excessive heat! Watch surrounding components! Resolder new component afterwards.

E-commerce order number: L50634-Z97-C379
 E-commerce order name: CONNECTOR CAMERA-SOCKET
 Soldering temperature: ~ 360°C TIP Temp.
 IRIS Diagnose Code: BA000 Accessories / Camera

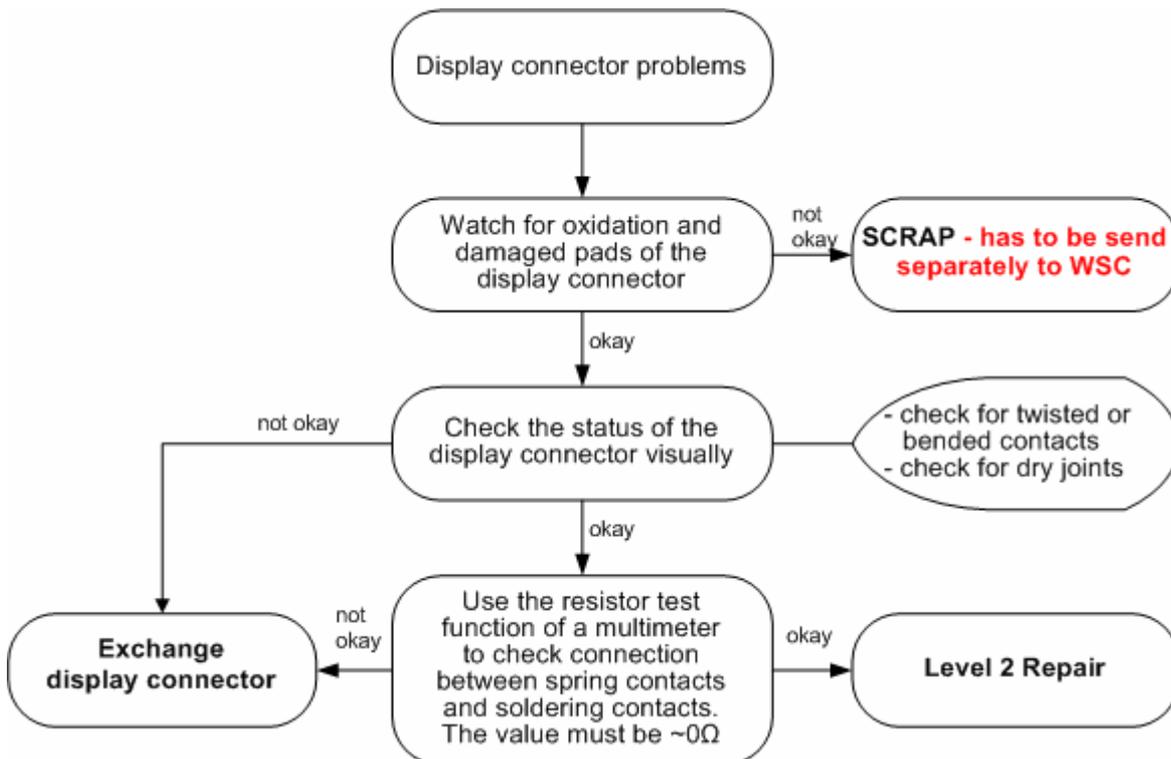
Connector DISPLAY

Fault Symptoms	
Customer: Display problems, like missing lines or columns on the LCD or display contrast problems or illumination problems	GRT: Display problems

Use hot air blower to remove defective component. Avoid excessive heat! Watch surrounding components!
Resolder new component afterwards.

E-commerce order number: L50634-Z97-C380
E-commerce order name: CONNECTOR DISPLAY 20POL
Soldering temperature: ~ 360°C TIP Temp.
IRIS Diagnose Code: 21000 Display / Performance
22000 Display / Background Illumination

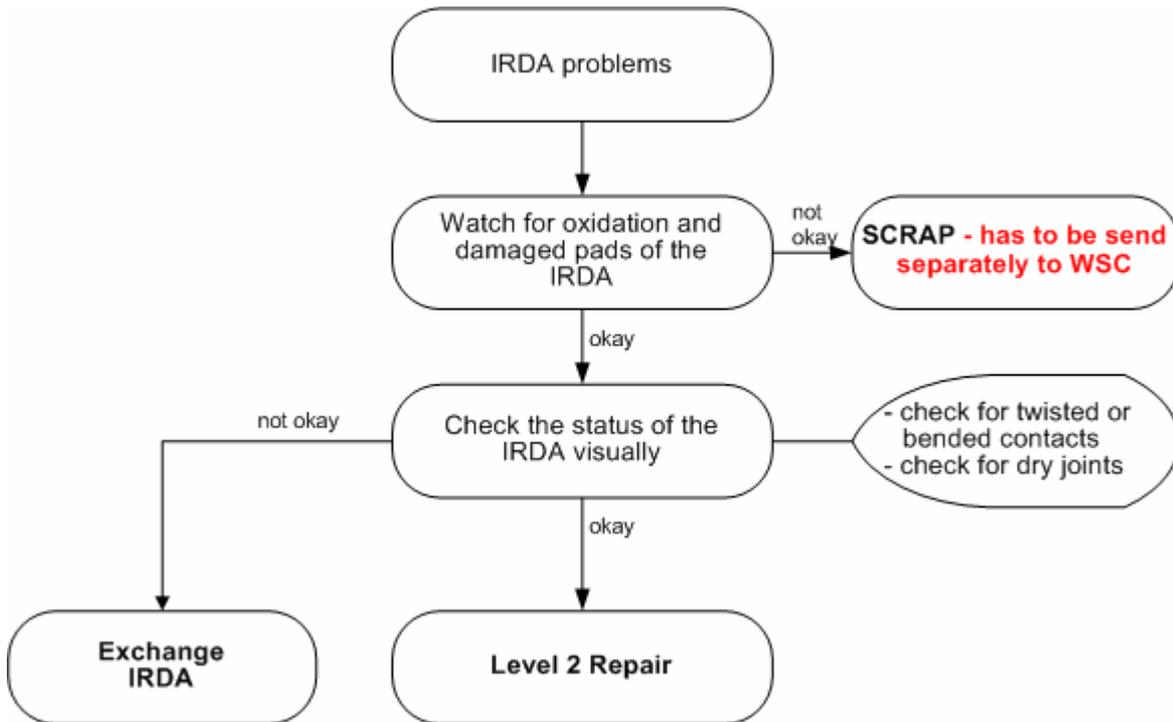
Fault Symptoms	
Customer: No infrared connection possible	GRT: Tbd.

Use hot air blower to remove defective component. Avoid excessive heat! Watch surrounding components! Resolder new component afterwards.

E-commerce order number: L36197-F5008-F492
 E-commerce order name: IRDA 115.2 KBIT
 Soldering temperature: ~ 360°C TIP Temp.
 IRIS Diagnose Code: 41100 Interfaces / IRDA / No Function
 41300 Interfaces / IRDA / Mechanical Damage

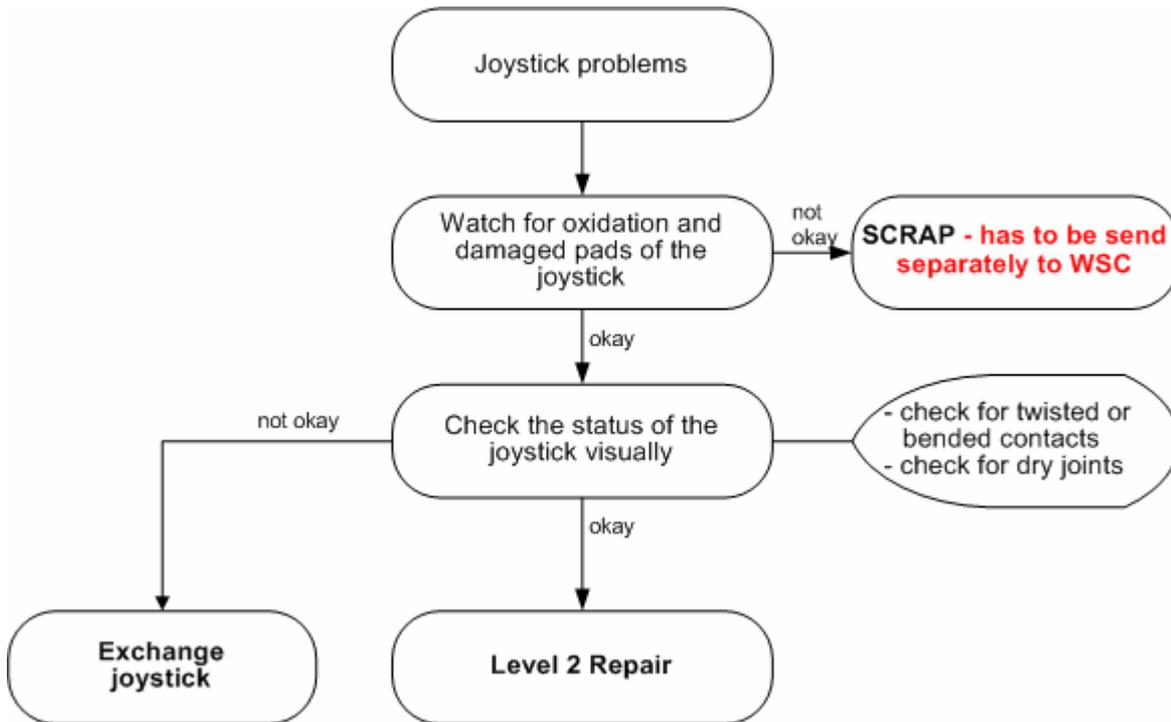
Fault Symptoms	
Customer: Joystick malfunction	GRT: Tbd.

Use hot air blower to remove defective component. Avoid excessive heat! Watch surrounding components!
 Resolder new component afterwards.

E-commerce order number: L36315-Z77-C218
 E-commerce order name: JOYSTICK
 Soldering temperature: ~ 360°C TIP Temp.
 IRIS Diagnose Code: 32100 Keys / Main / No Function
 32200 Keys / Main / Reduced Functionality
