ST55

Level 2.5

Repair Documentation

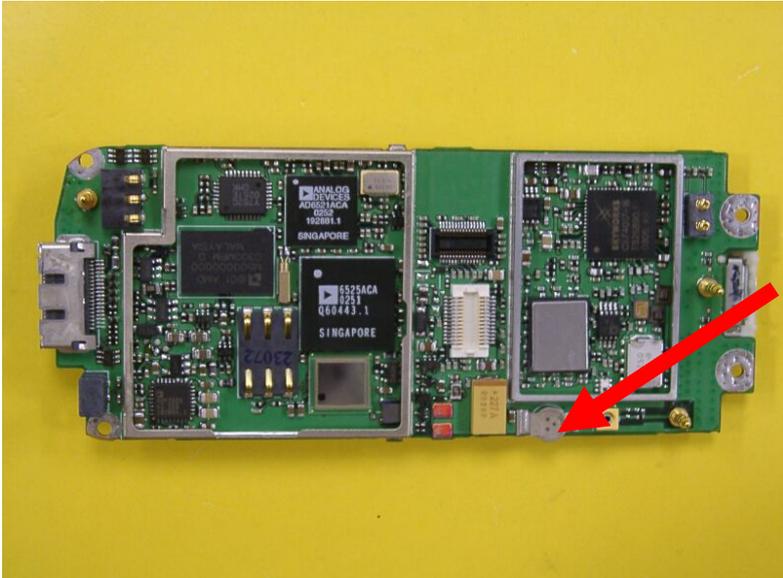
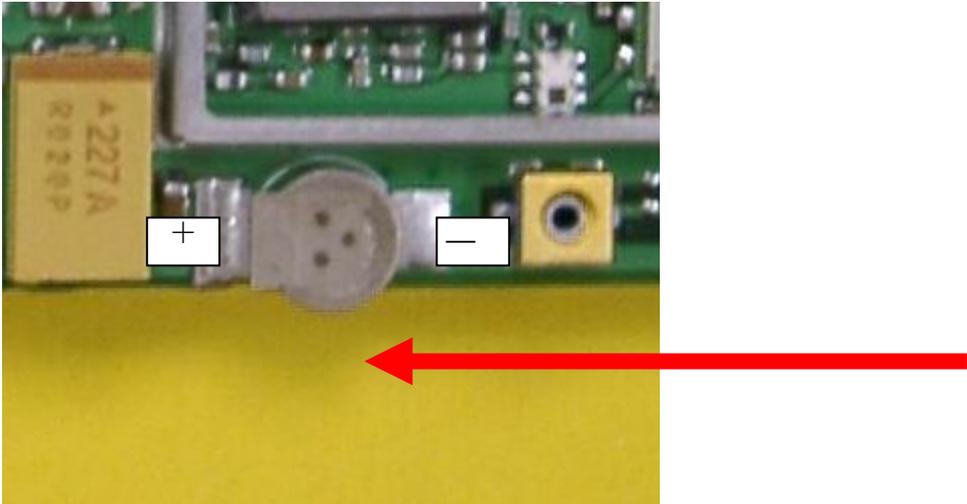
Time/Clock will reset each time power on.  
No call records can be saved.

Visual check and measure with a multimeter to detect if the RTC is oxidized or deformed.

1. Remove the defected RTC by Hot Air Blower (350°C ~ 400 °C) (350~400 °C).
2. Put on new RTC and add solder at the "+" side first.
3. Then add solder at the "-" side.

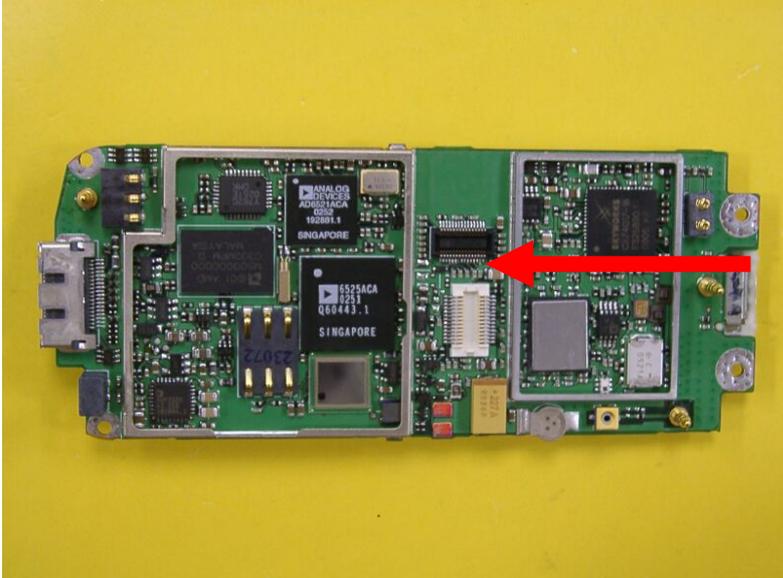
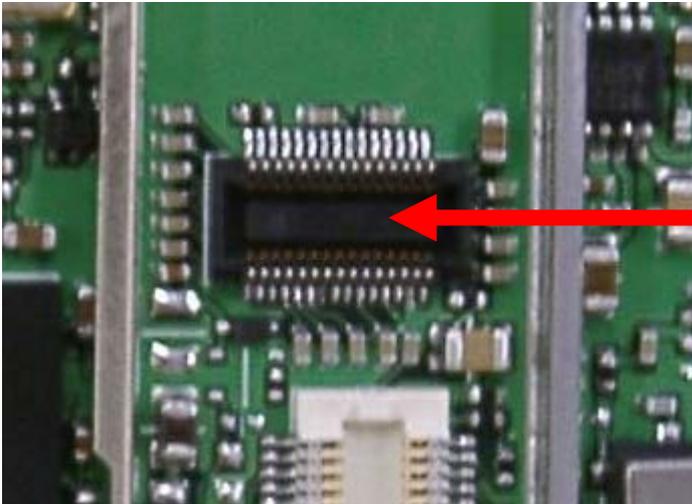
No screen or wrong display.

Visual check and measure with a multimeter to detect if pins are cold, insufficient soldering, oxidized or deformed.

- 1.Re-solder this connector if cold or insufficient soldering.
- 2.Use hot blower to remove defective connector and add solder on pads.  
Avoid excessive heat! Watch surrounding component!
- 3.Heat and put on a new connector to enhance adhesion.
- 4.Re-solder new connector afterwards.

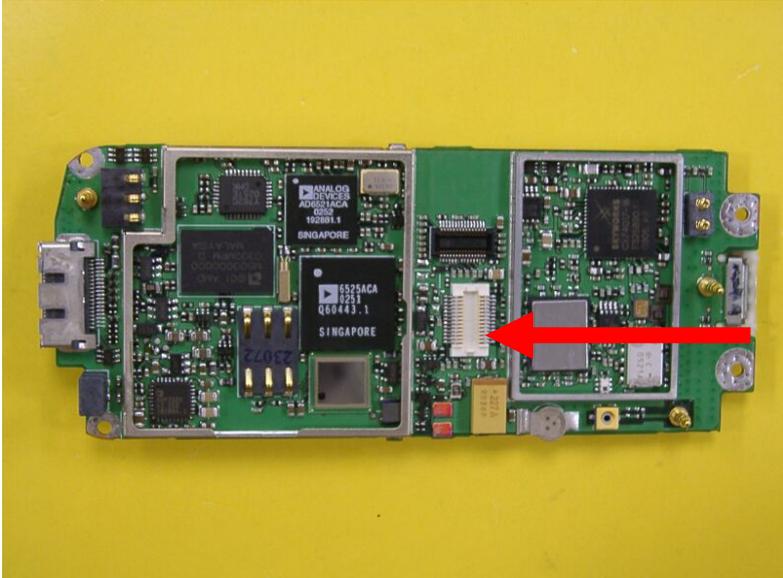
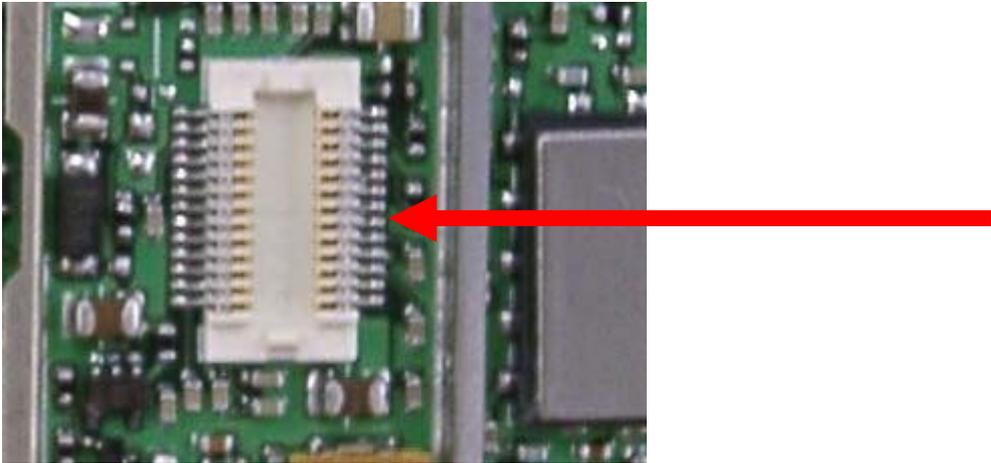
The picture captured by camera can't be shown on screen or abnormal display.

Visual check and measure with a multimeter to detect if the pins are cold, insufficient soldering, oxidized or deformed.

- 1.Re-solder this connector if cold or insufficient soldering.
- 2.Use hot blower to remove defective connector and add solder on pads.  
Avoid excessive heat! Watch surrounding component!
- 3.Heat and put on a new connector to enhance adhesion.
- 4.Re-solder new connector afterwards.

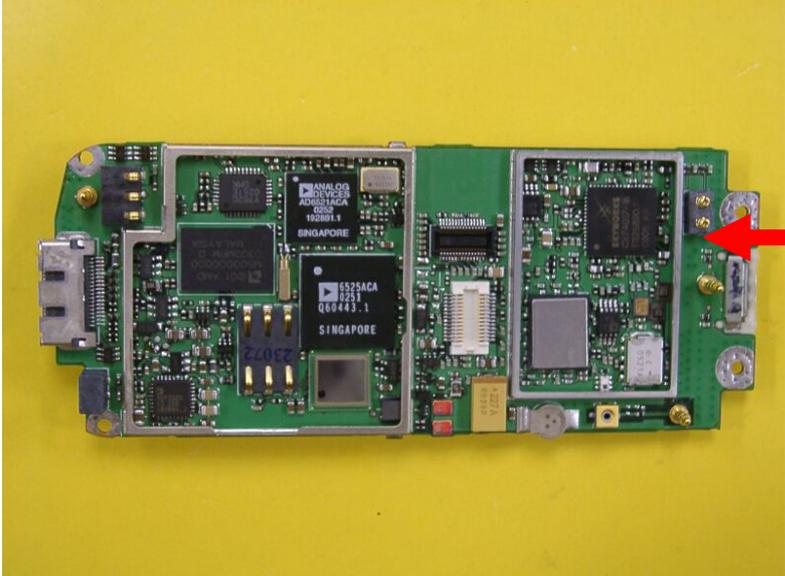
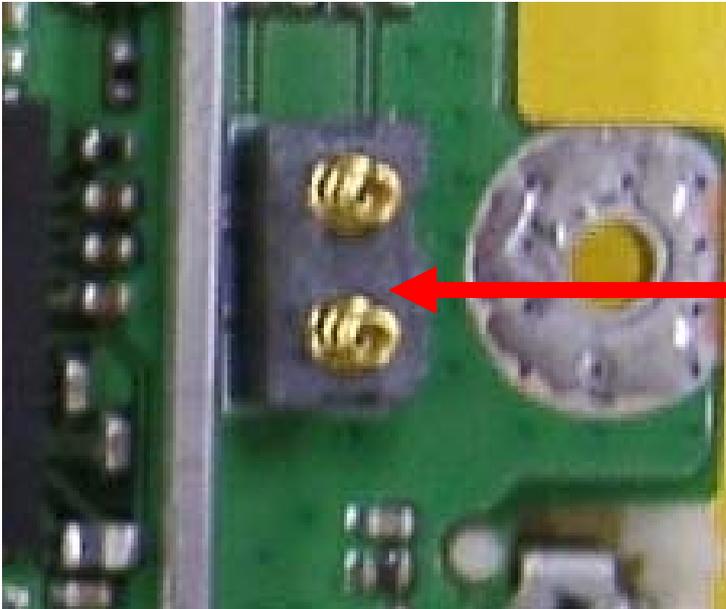
No ring tone while setting and a call coming.

Visual check if the springs are oxidized or deformed.

1. Use hot blower to remove the defective connector.  
Avoid excessive heat! Watch surrounding components!
2. Add solder on pads.
3. Heat and put on a new connector to enhance adhesion.

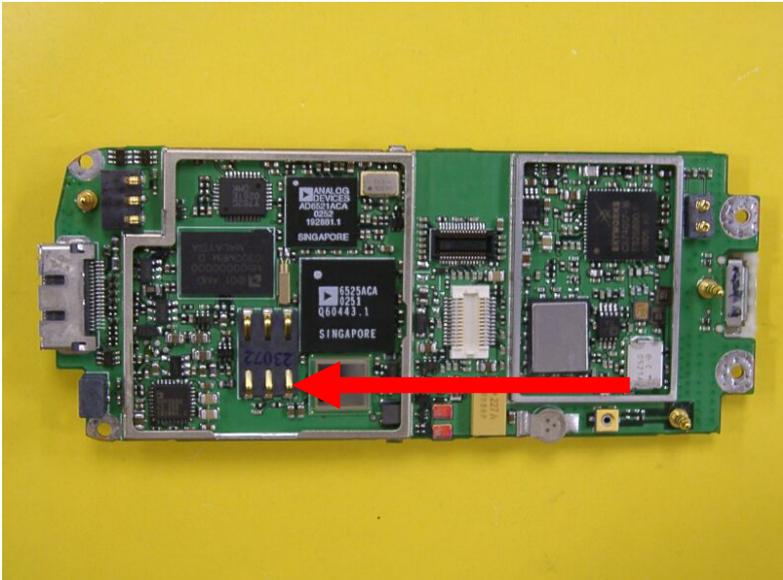
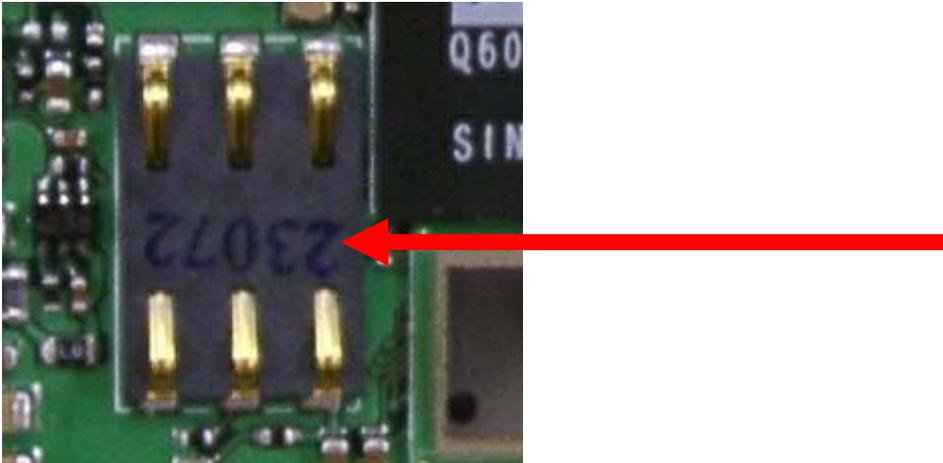
Always "Insert SIM card" showed under normal operation.

Visual check and measure with multimeter if pins are cold, insufficient soldering, oxidized or deformed.

- 1.Re-solder this connector if cold or insufficient soldering.
- 2.Use hot blower to remove the defective connector if oxidized or deformed and absorb remaining tin on pads.
- 3.Put on new connector and add solder on pins in diagonal sequence.

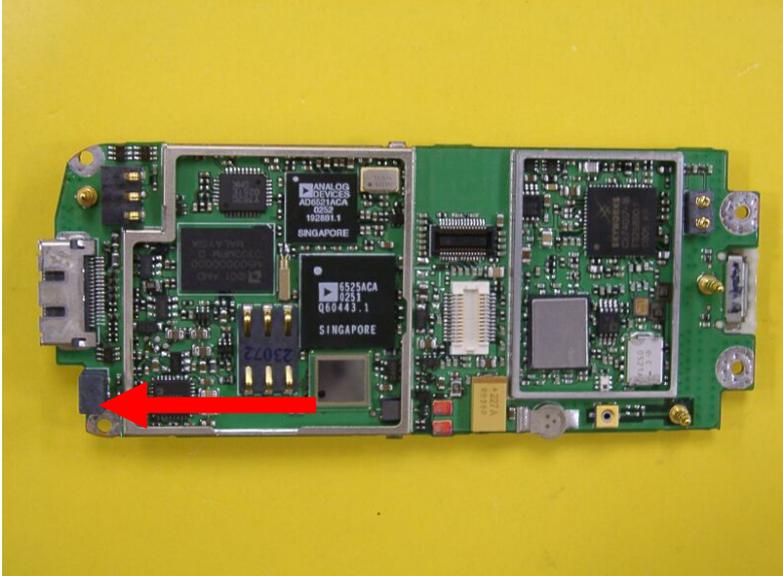
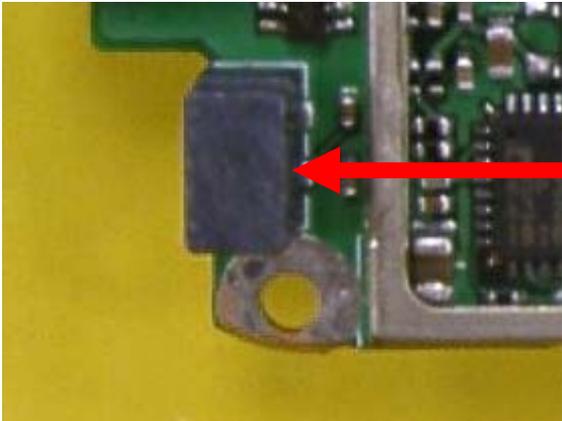
The called party can't hear any voice.

Measure pin2 to R206 with multimeter to check cold or insufficient soldering.

1. Use hot blower to remove the defective connector.  
Avoid excessive heat! Watch surrounding components!
2. Add solder on pads.
3. Heat and put on a new connector to enhance adhesion.

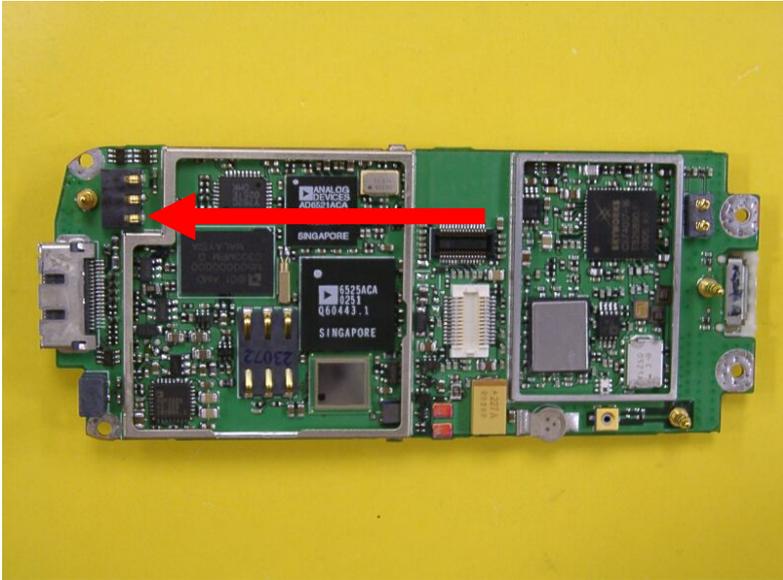
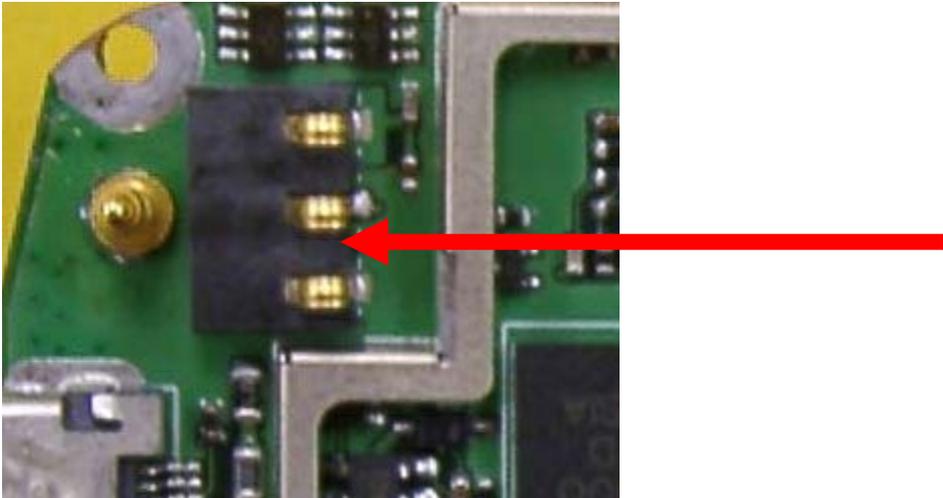
- Can't power on under normal operation.
- Can't charge by this mobile when power off.

Eye check pins if oxidized or deformed.  
Measure pins to test points (VBAT, GND) by the multimeter to check conductivity.

1. Use hot blower to remove the defective connector.  
Avoid excessive heat! Watch surrounding components!
2. Add solder.
3. Heat and put on a new connector to enhance adhesion.
4. Re-solder if needed.

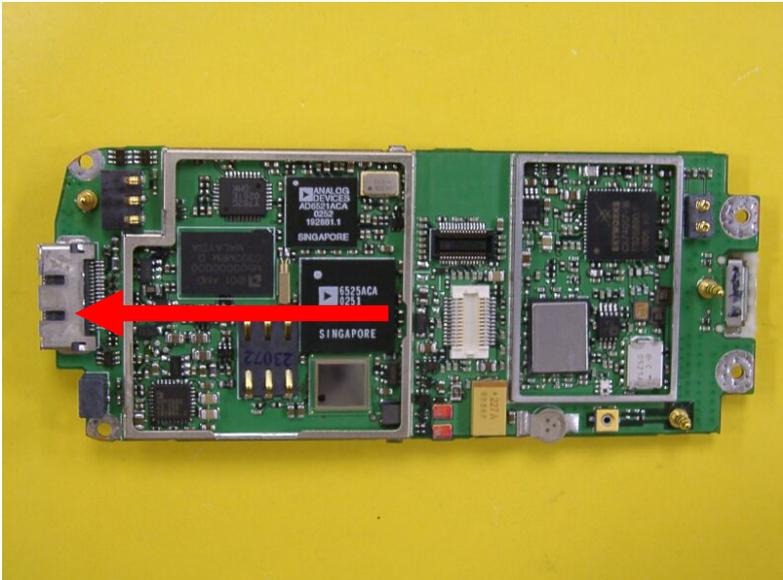
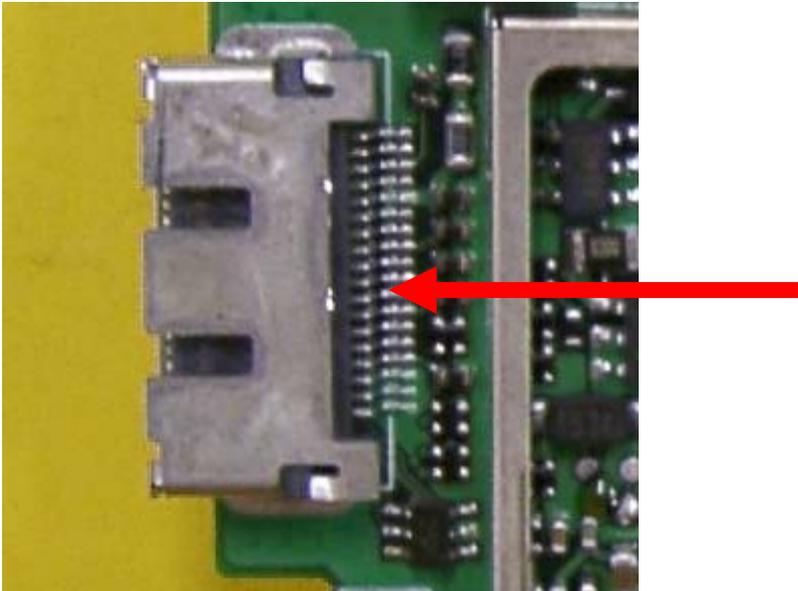
Can't charge. No charging icon shown when plugging the charger in. Earphones can't be used.

Visual check and measure with multimeter if pins are cold, insufficient soldering, oxidized or deformed.

1. Re-solder this connector if cold or insufficient soldering.
2. Use hot blower to remove the defective connector.  
Avoid excessive heat! Watch surrounding components!
3. Add solder.
4. Heat and put on a new connector to enhance adhesion.
5. Re-solder if needed.

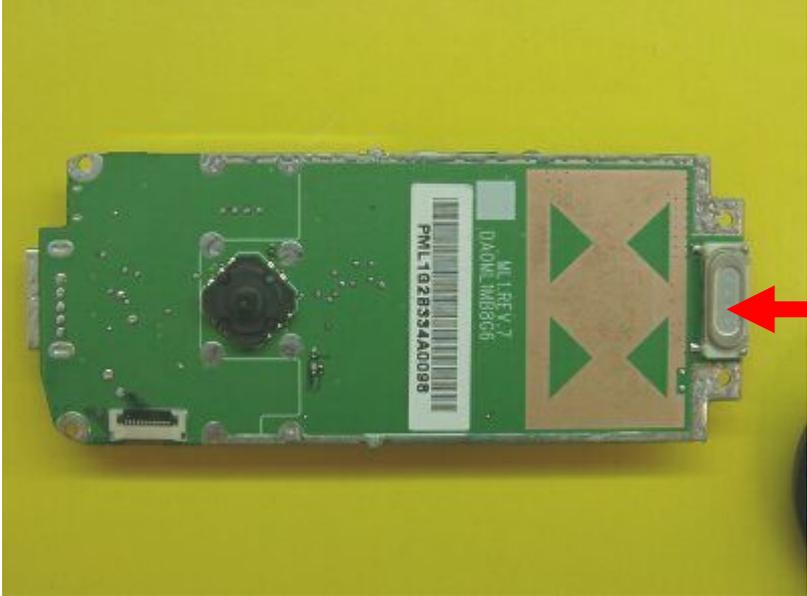
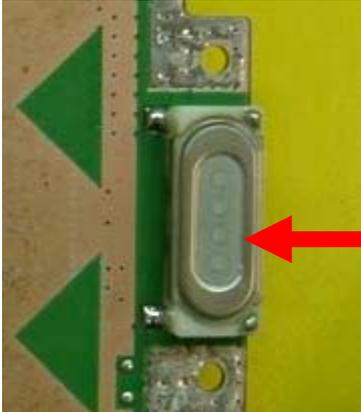
The caller can't hear any voice.

Visual check and measure with multimeter to detect if pins are cold, insufficient soldering, oxidized or deformed.

1. Re-solder this connector if cold or insufficient soldering.
2. Heat and remove the defective earpiece by Soldering Iron (350°C ± 20 °C) from the top side.
3. Put on a new earpiece.
4. Heat and press the earpiece to the right position gently.  
Avoid excessive heat! Watch surrounding component!
5. Re-solder if needed.

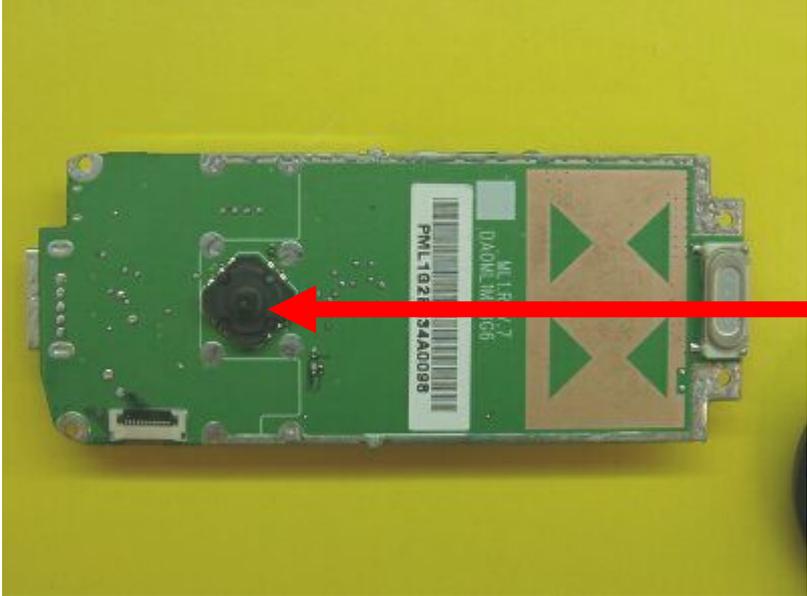
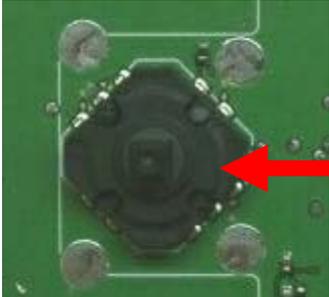
The joystick will be no function under normal operation.

Visual check and measure with multimeter if pins are cold, insufficient soldering, oxidized or deformed.

- 1.Re-solder this connector if cold or insufficient soldering.
- 2.Use hot blower to remove the defective connector if oxidized or deformed and absorb remaining tin on pads.
- 3.Put on new connector and add solder on pins in diagonal sequence.

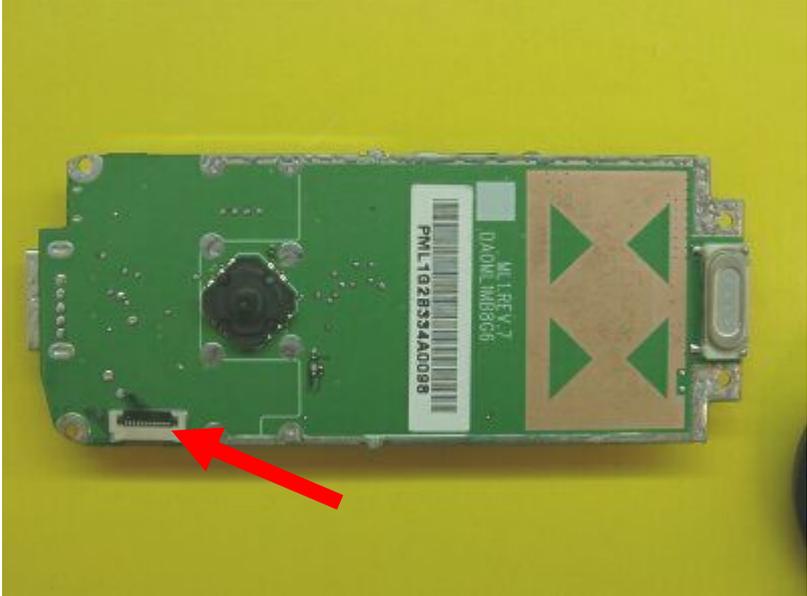
- Can't power on/off.
- No response while pressing keys under normal operation.

Visual check and measure with multimeter if pins are cold, insufficient soldering, oxidized or deformed.

1. Re-solder this connector if cold or insufficient soldering.
2. Use hot blower to remove the defective connector.  
Avoid excessive heat! Watch surrounding components!
3. Add solder.
4. Heat and put on a new connector to enhance adhesion.
5. Re-solder if needed.

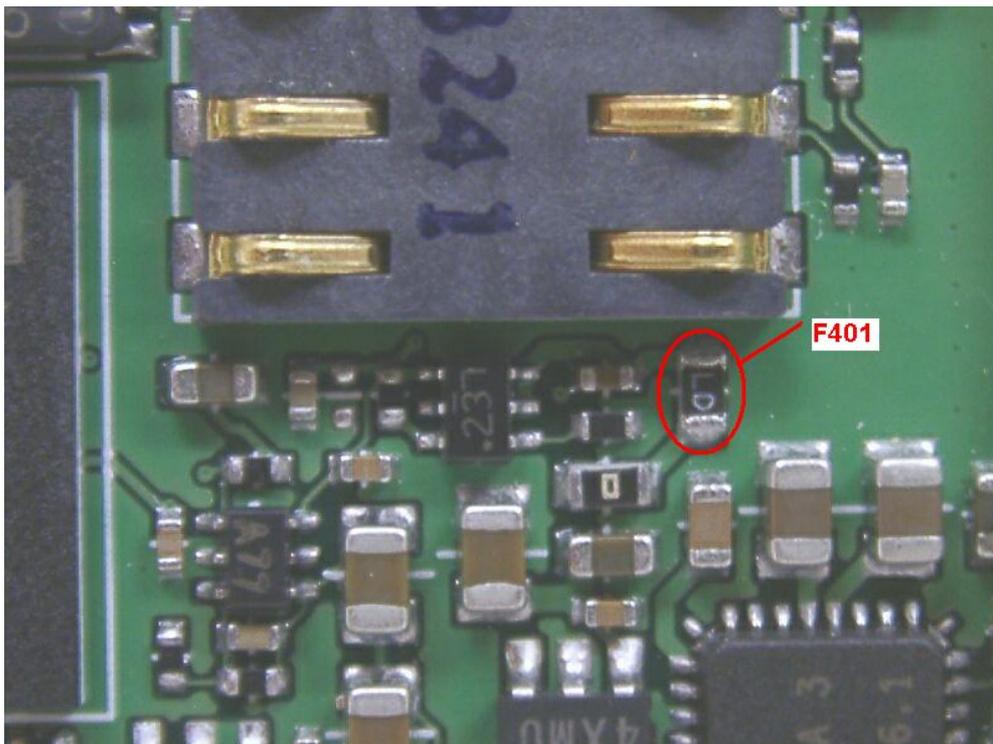
Figure 12.1: ST55 FUSE (F401)

Charging Function OK, D7L (AT command) through cable fail

Visual check and measure with multimeter to detect if pins are cold, insufficient soldering, oxidized or deformed.

1. Re-solder the fuse if cold or insufficient soldering.
2. Use hot blower to remove the defective fuse.  
Avoid excessive heat! Watch surrounding components!
3. Add solder.
4. Heat and put on a new fuse to enhance adhesion.
5. Re-solder if needed.
