# Service Repair Documentation

## Level 2.5 - C65

## Introduction

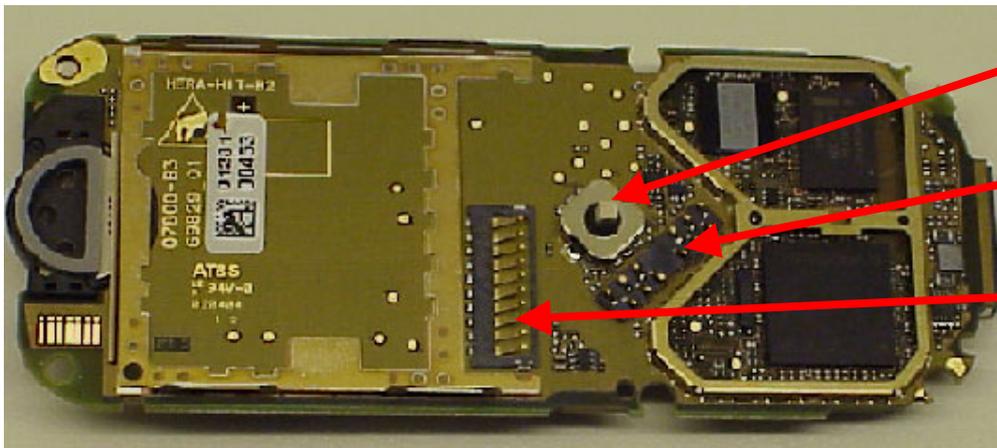
- Joystick SW
- Connector Board to Board
- Connector Display

Jigs, Tools and Working materials for all described repairs:

- hot air blower
- soldering gun
- tweezers
- flux
- solder

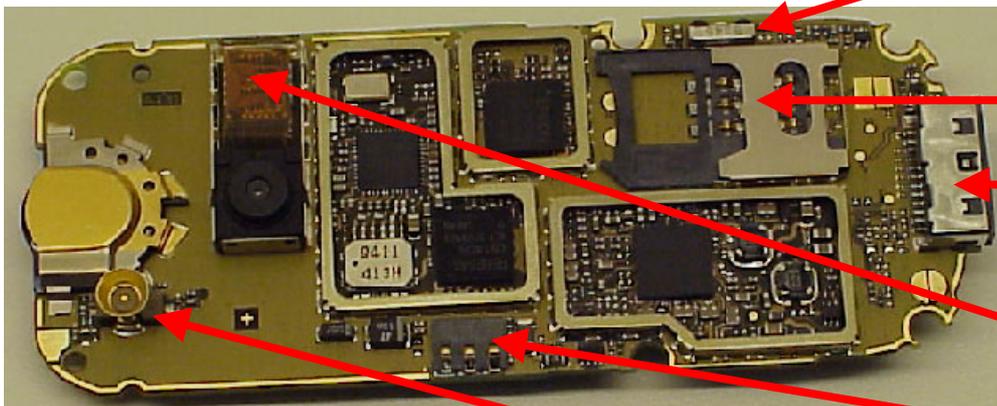
- Diode IRDA
- Connector SIM CARD READER
- Connector IO JACK
- Connector BATTERY
- Connector BOARD TO BOARD
- Connector RF
