# Kapalua Schematic

BDQ11/LA1601 Schematic with Capture CIS and Function field  
uFCPGA Banias  
12-27-2002  
REV: 0.4

Title		
Cover Sheet		
Size	Document Number	Rev
	BDQ11/LA-1601	0.4
Date:	星期五, 十二月 27, 2002	Sheet 1 of 56

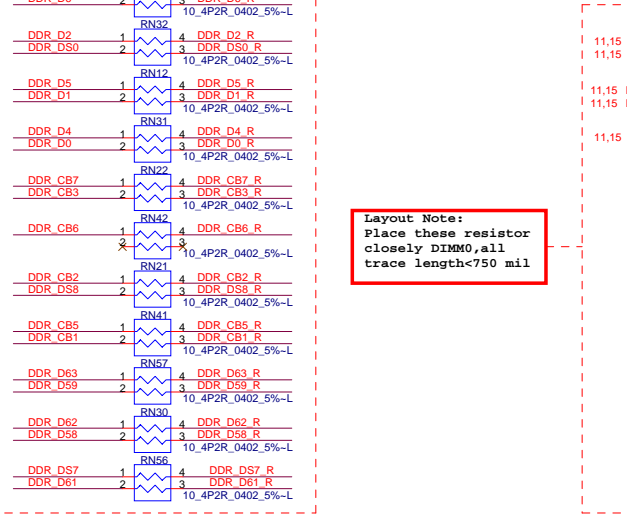
**Layout Note:**  
Place these resistor closely DIMM0, all trace length Max=1.3"
