A3 BLOCK DIAGRAM

North Bridge	DDR	CPU
A3N	855GM	266	Celeron/ Banias/ Dothan(400)
A3L	852GM	266	Celeron/ Banias/ Dothan(400)
A3Ne/A6Ne	855GME	333	Celeron/ Banias/ Dothan(400)
	852GME	333	Celeron/ Banias/ Dothan(400)/ Dothan(533)
A3Le	852GMV	266	Celeron/ Banias/ Dothan(400)/ Dothan(533)

FILE LIST

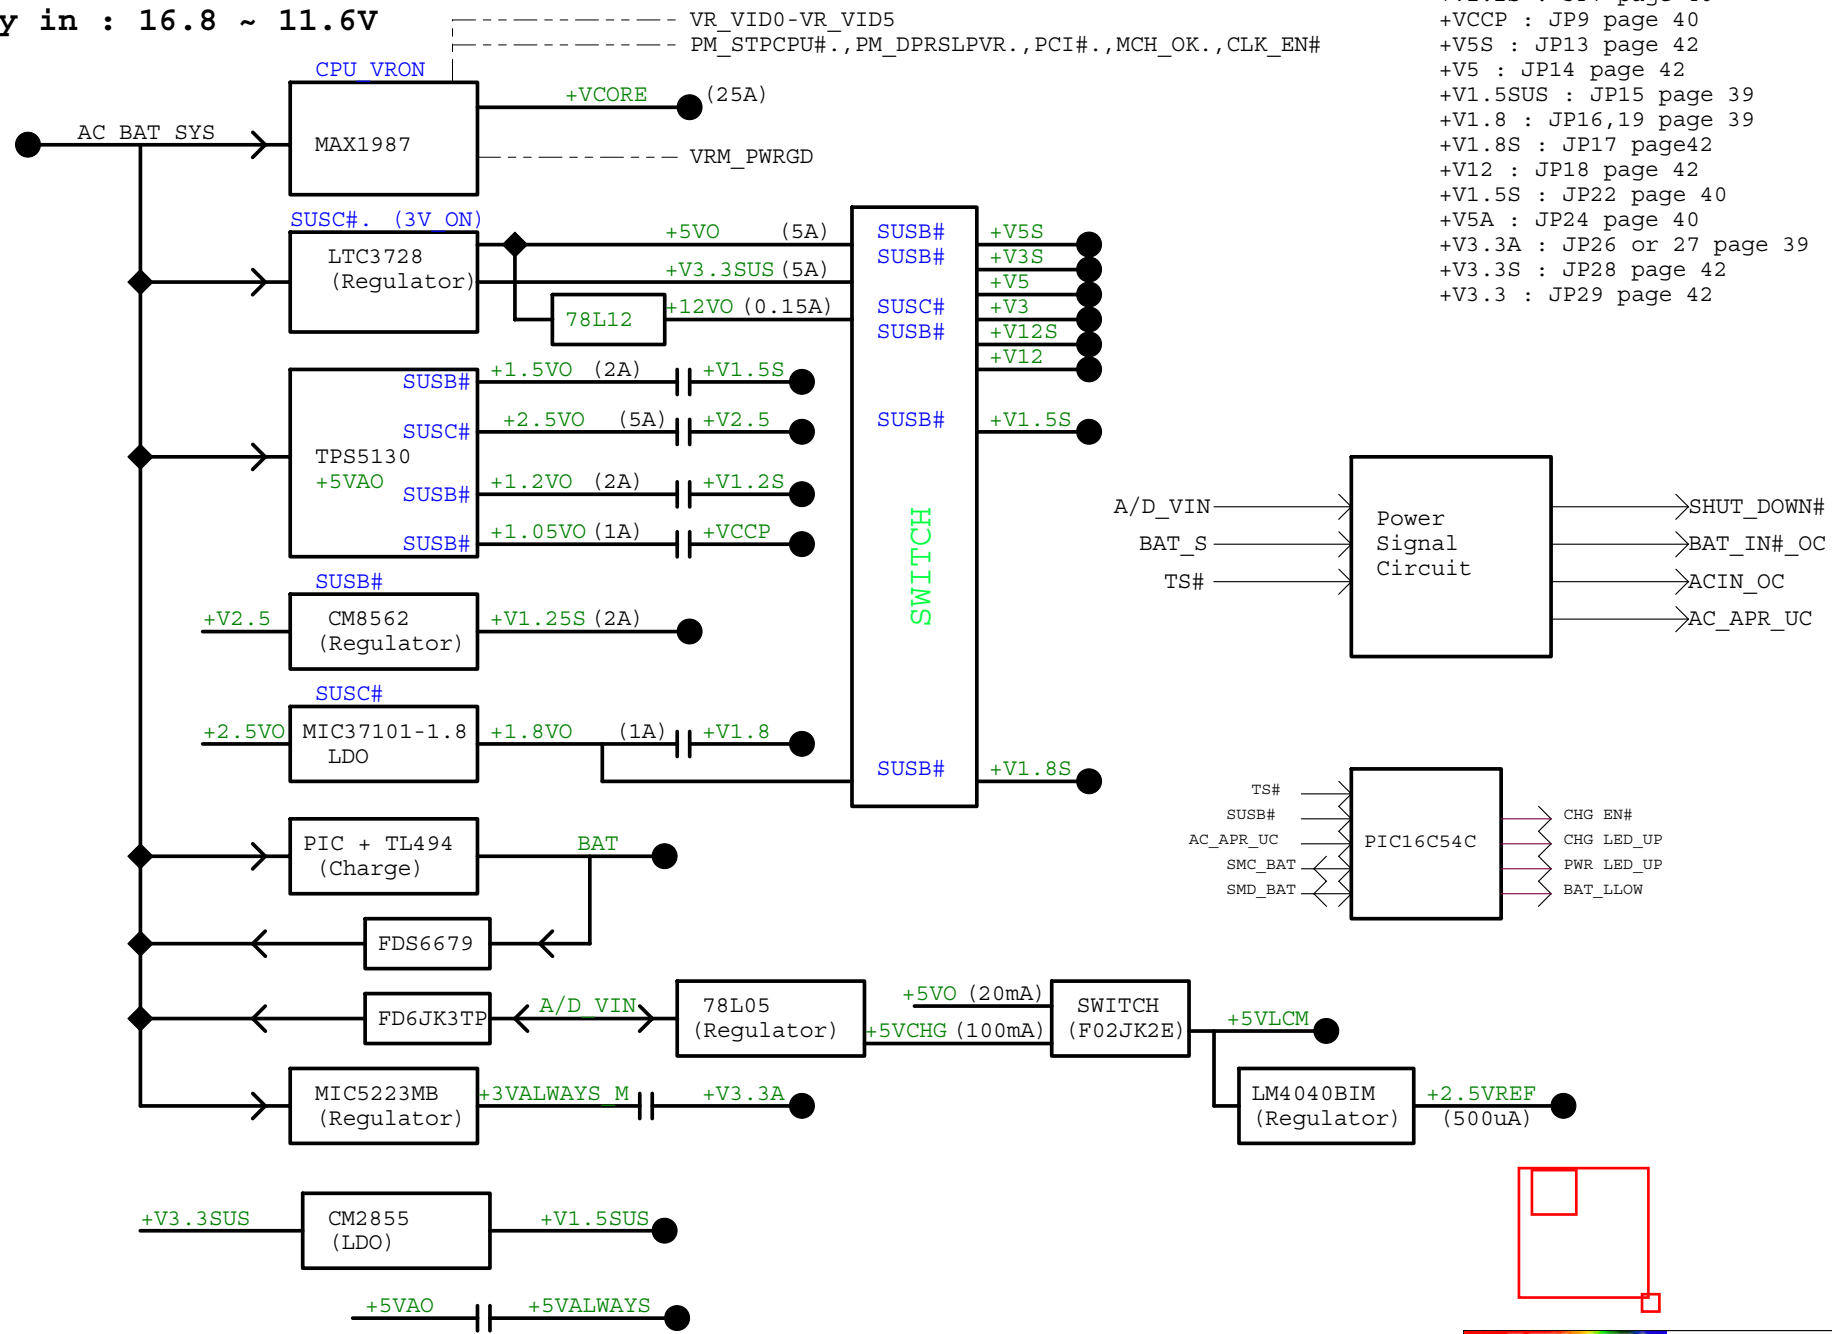
System work voltage

Adapter in : 19.5 ~18.5 V

Battery in : 16.8 ~ 11.6V

- +V1.25S : JP4,5 page 39
- +V2.5 : JP6 page 40
- +V1.2S : JP7 page 40
- +VCCP : JP9 page 40
- +V5S : JP13 page 42
- +V5 : JP14 page 42
- +V1.5SUS : JP15 page 39
- +V1.8 : JP16,19 page 39
- +V1.8S : JP17 page42
- +V12 : JP18 page 42
- +V1.5S : JP22 page 40
- +V5A : JP24 page 40
- +V3.3A : JP26 or 27 page 39
- +V3.3S : JP28 page 42
- +V3.3 : JP29 page 42

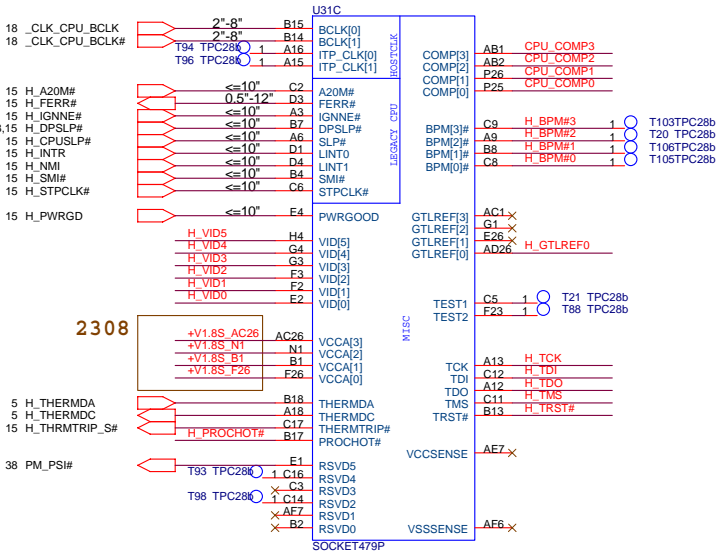
CPU PLL CIRCUITS
1.71V - 1.89V(+/- 5%)
SO-S1M: 0.3A

Celeron	Banias	Dothan (400)	Dothan (533)
Frequency	100	100	100	133
VCCA[1:3]	1.8V	1.8V	1.8V	NC
VCCA[0]	1.8V	1.8V	1.8V	1.5V
U54 switch to	Pin 3,4		Pin 1,2

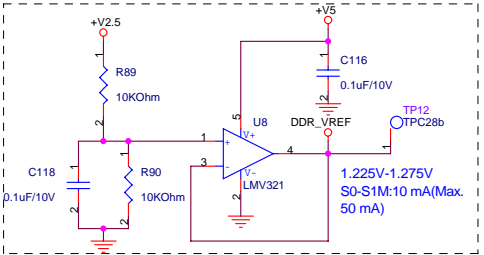
1.23125V-1.26875V
SO-S1M:Max. 80 mA
S3: 0 mA

Intel suggested that DDR_VREF should be turned off in S3-S5. But measure the leakage because there is no +V2.5S.

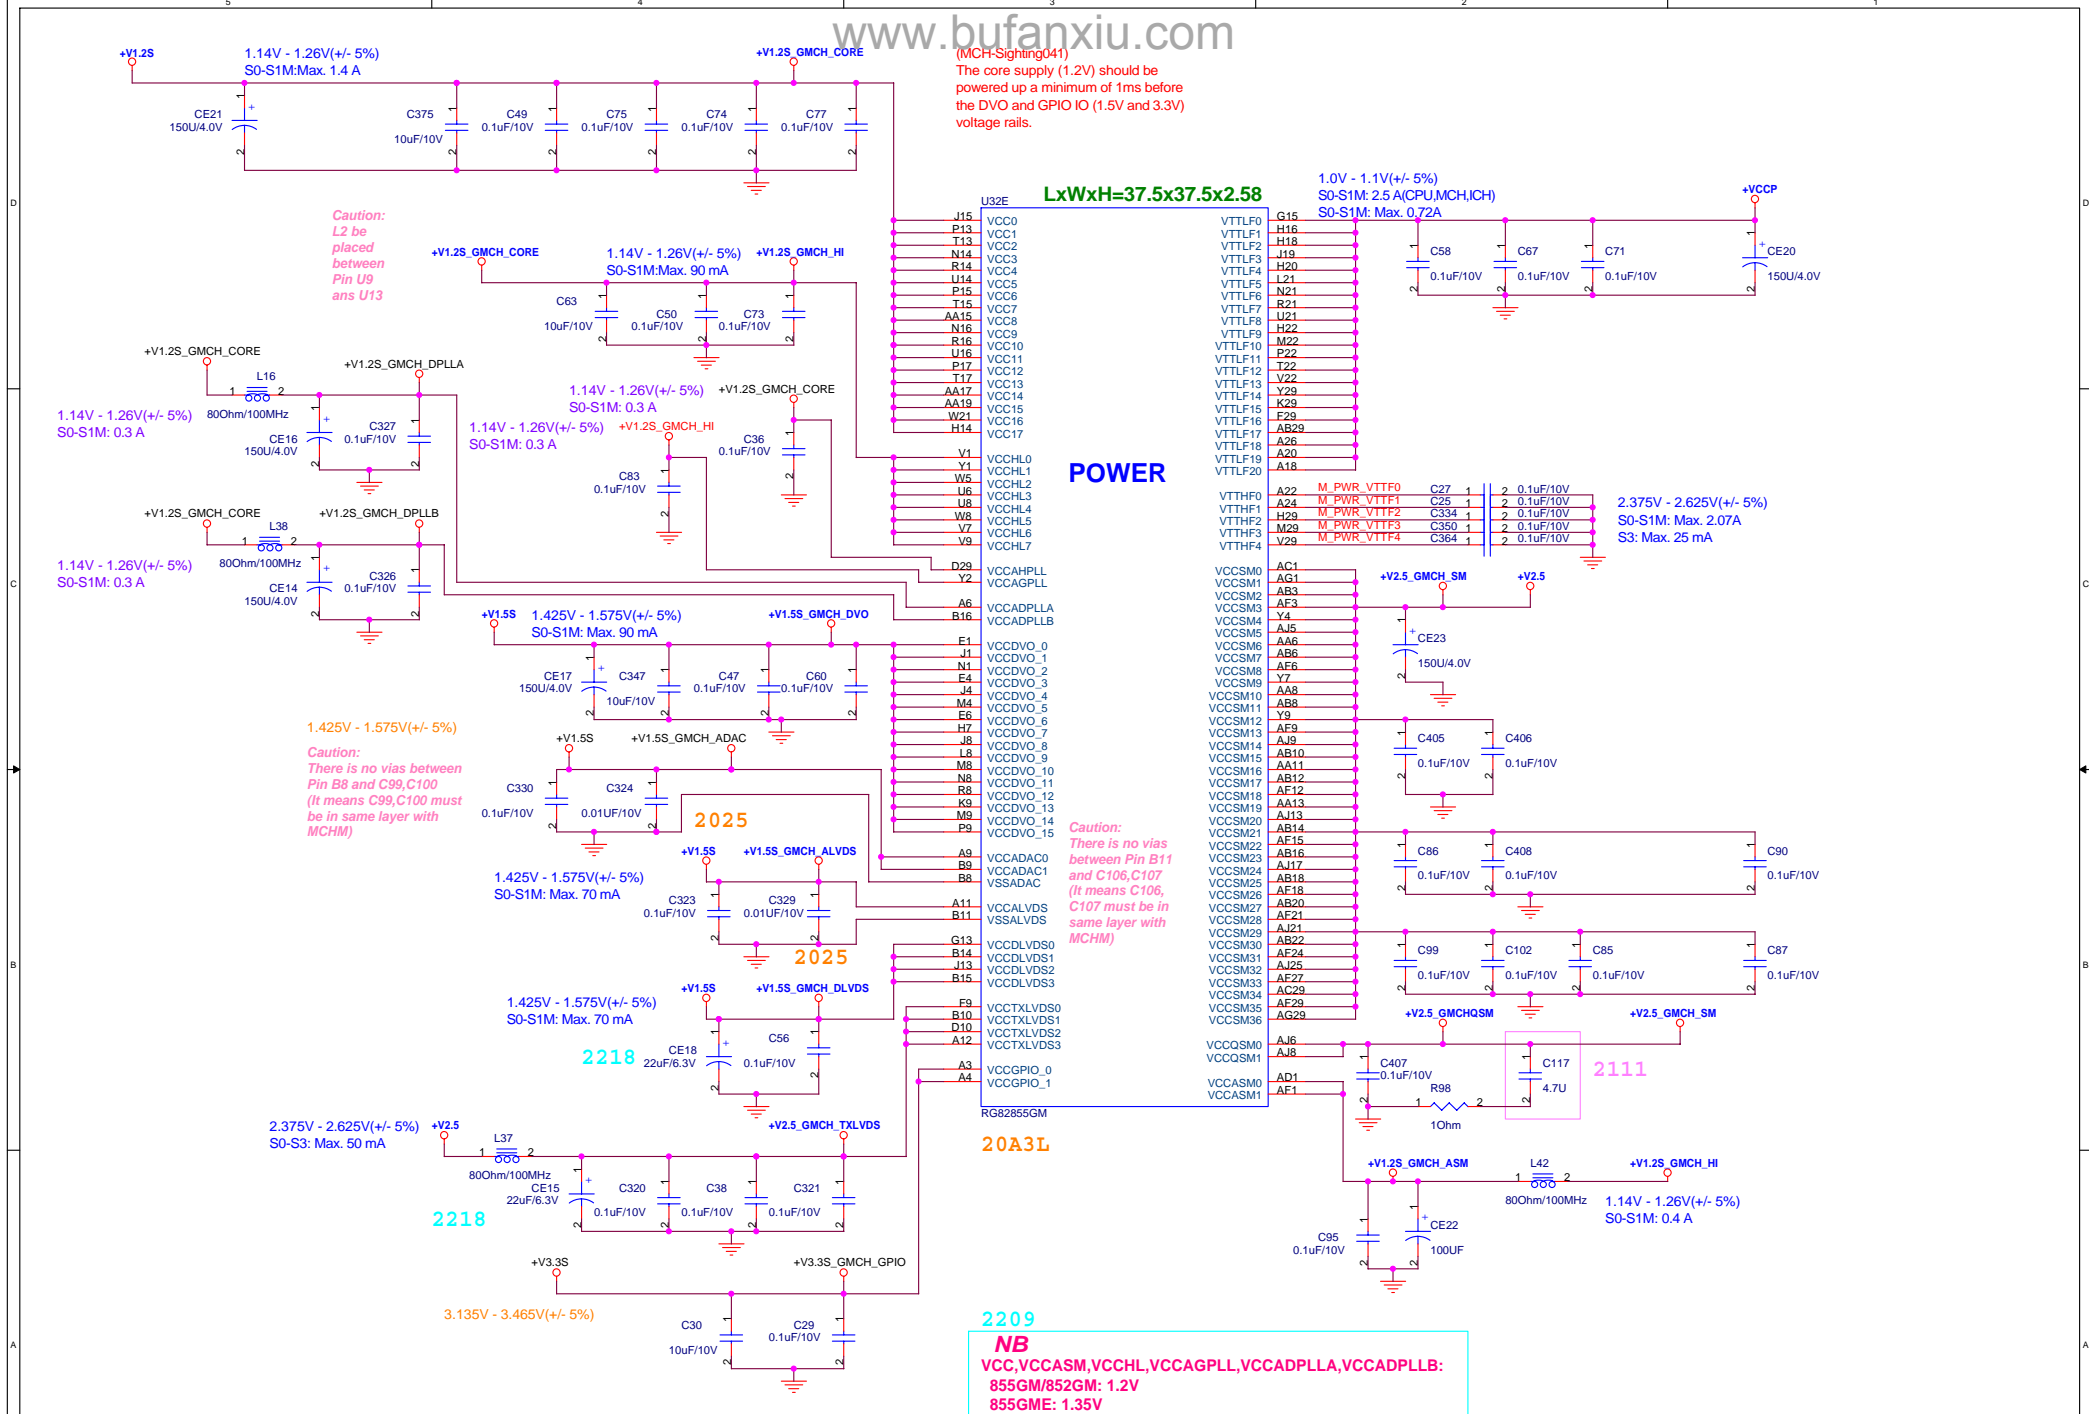
POWER

Caution:
There is no vias between Pin B11 and C106, C107 (It means C106, C107 must be in same layer with MCHM)

NB
VCC,VCCASM,VCCHL,VCCAGPLL,VCCADPLL,VCCADPLLB:
855GM/852GM: 1.2V
855GME: 1.35V
852GME/852GMV: 1.5V

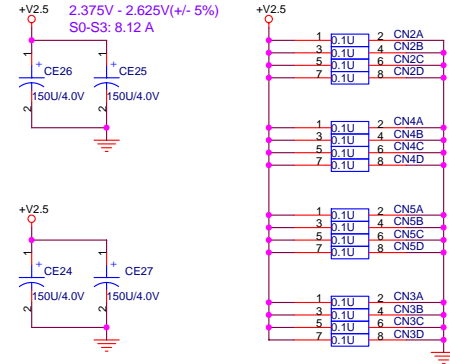
FOR +V2.5 DECOUPLING

2024
EMI : Close to DDR
socket power plane
of +V2.5

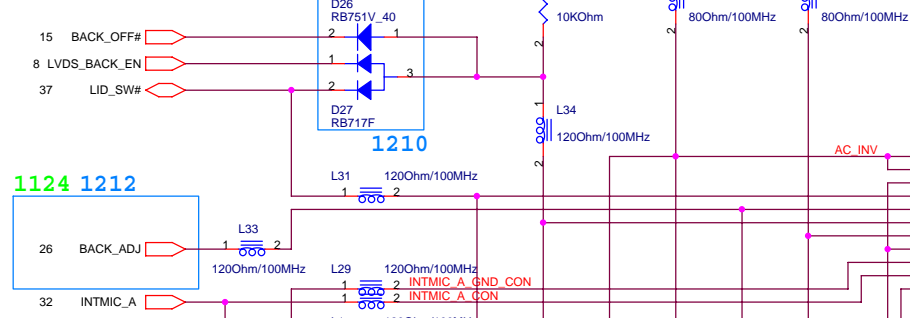
BIOS
BACK_ADJ: KBC output D/A signal (adjust voltage level) to adjust Back light.

A3N use D1 R:1.0 Inverter Board

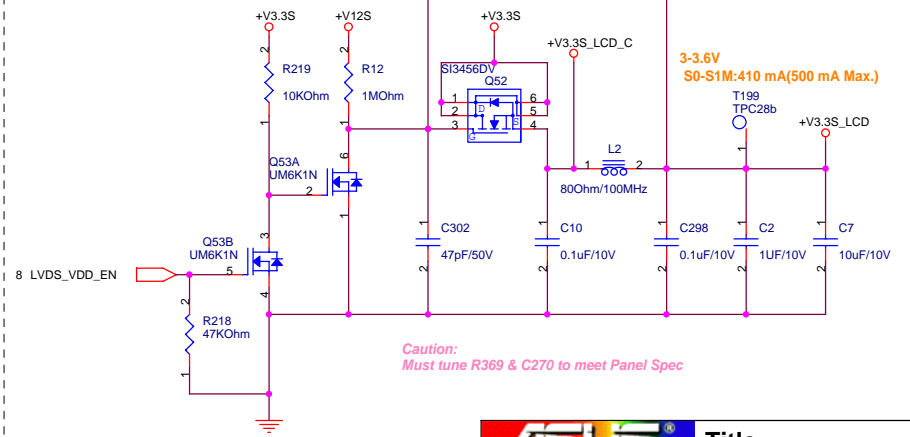
LCD Power

SI3865: US\$0.22

Caution: Must tune R369 & C270 to meet Panel Spec

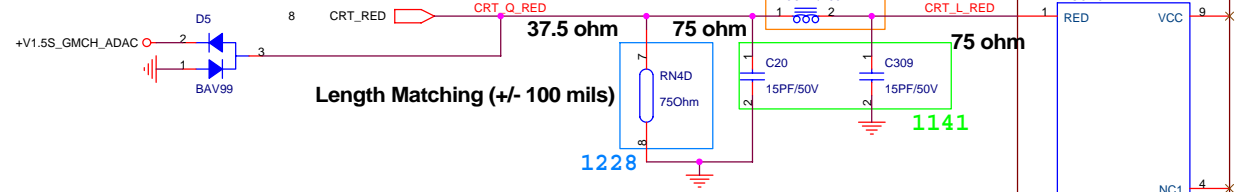
Place PI-Filter close to CRT (<= 200 mils)

Guarded by GND (Space >= 20mils)

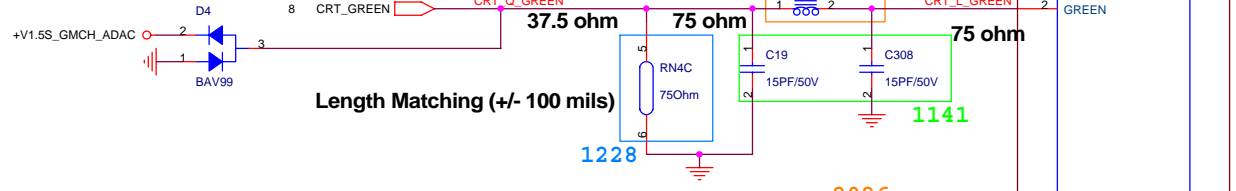
Guarded by GND (Space >= 20mils)

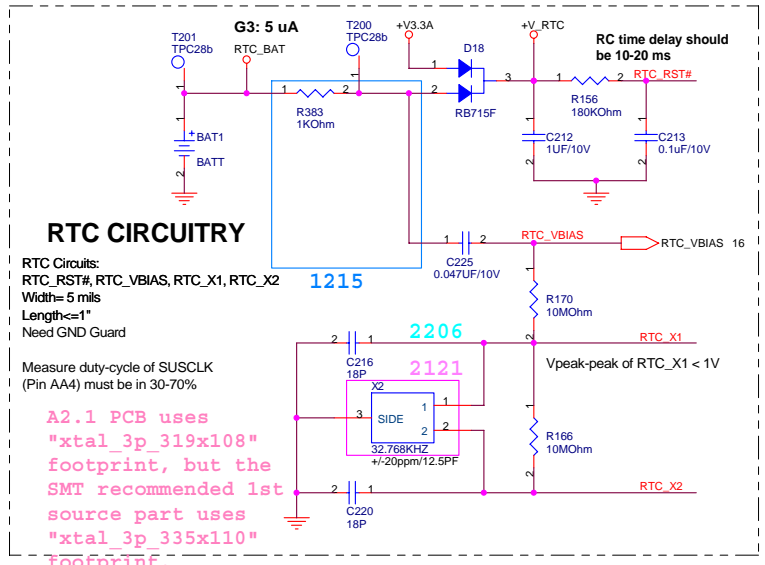
RTC CIRCUITRY

RTC Circuits:
RTC_RST#, RTC_VBIAS, RTC_X1, RTC_X2
Width= 5 mils
Length<=1"
Need GND Guard

Measure duty-cycle of SUSCLK
(Pin AA4) must be in 30-70%

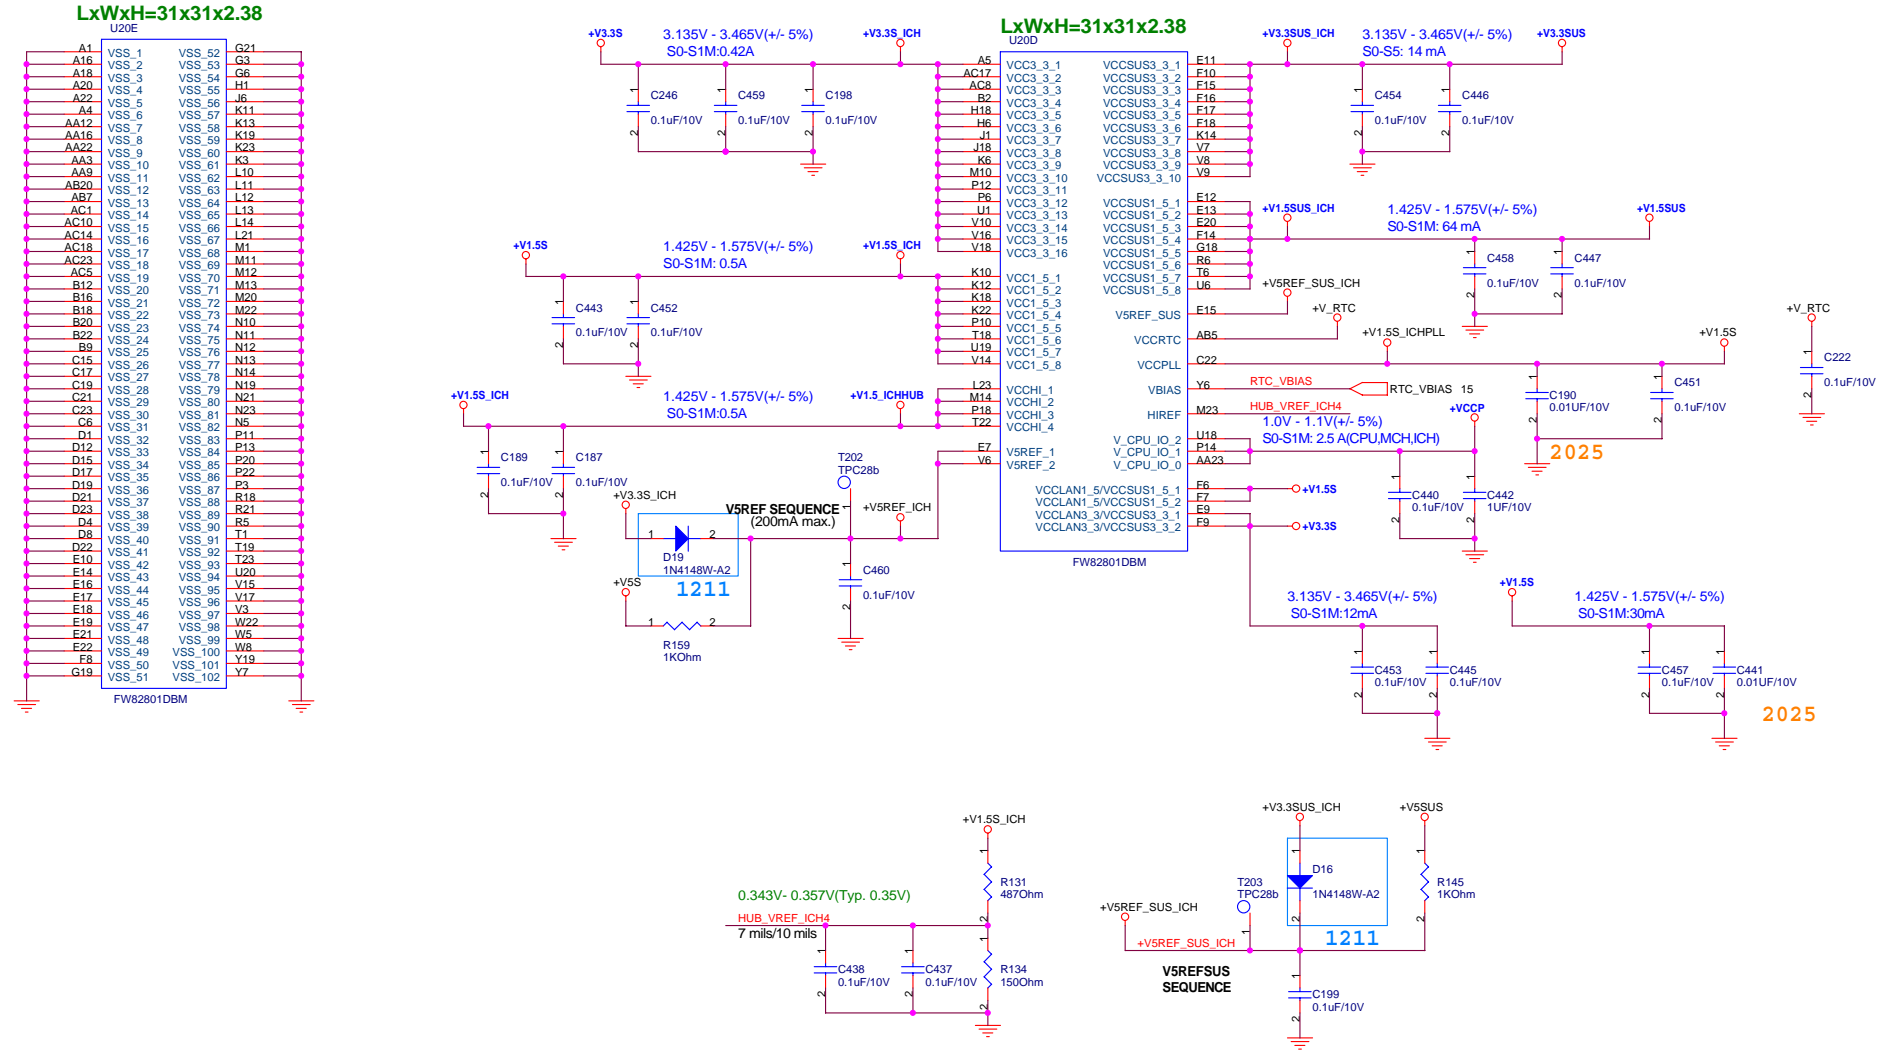
Caution:
 The VREF of HUB interface is 0.35V
 The VSWING of HUB interace is 0.8V
 But in Intel CRB, their naming convention will
 make people confused.

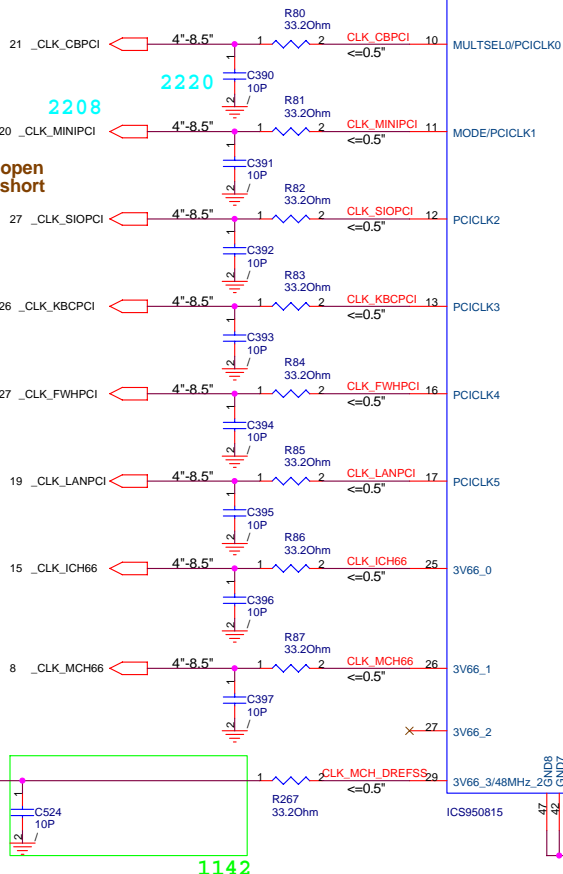
FS1	FS0	FUNCTION
0	0	66 MHz
0	1	100MHz
1	0	200MHz
1	1	133MHz

I2C address: D2H
3.3V+-5%
S1M: 40 mA
S0: 360 mA

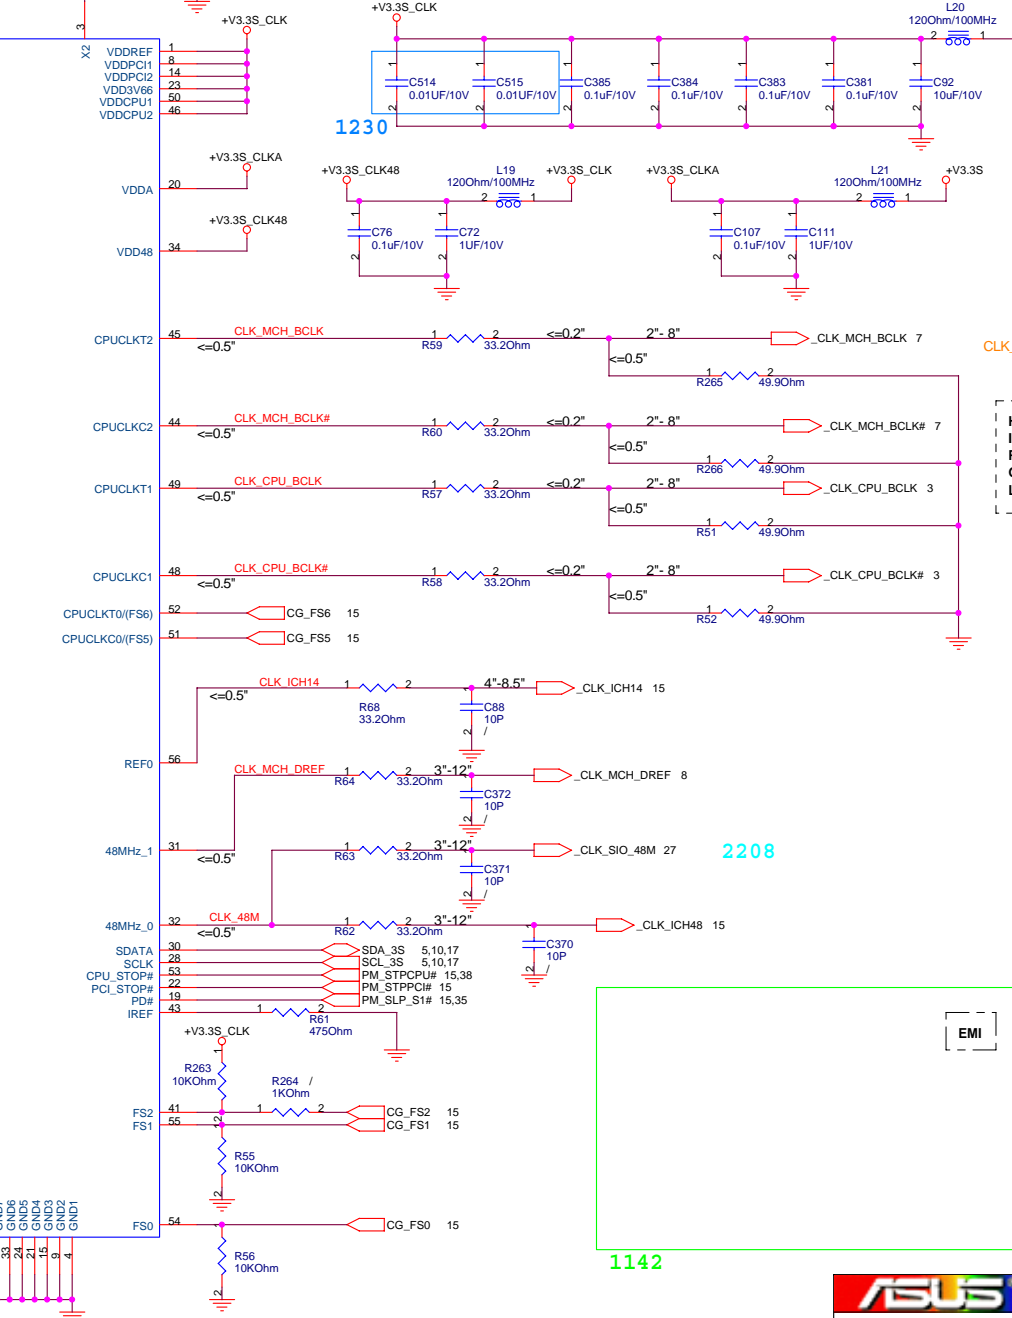
CLK_CPU_BCLK# must be low in C3

HOST_CLK GROUP
In L3 or L6
Pair Width/Space: 4/4 mils
Group Space: >= 25 mils
Length Match: +/- 10 mils

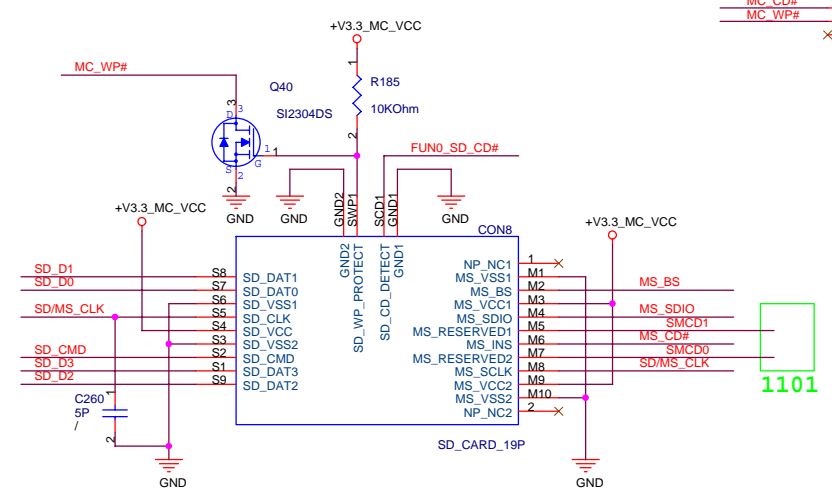
FUNSEL1	FUNSEL0	
0	0	Not Support
0	1	SmartMedia
1	0	MMC/SD
1	1	Memory Stick

MC_CD# : Memory Card Detect

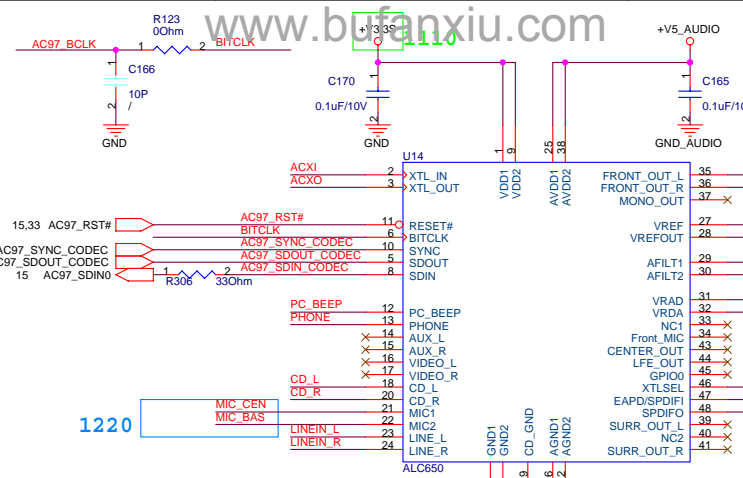
15 AC97_BCLK_ICH4
33 AC97_BCLK_MDC

R307 1 2 330hm AC97_BCLK
R305 1 2 330hm /CUSTOMER

0.1 to 6 inches
0.9 to 5.6 inches
0.1 to 0.4 inches

T type routing, place R at branch point.

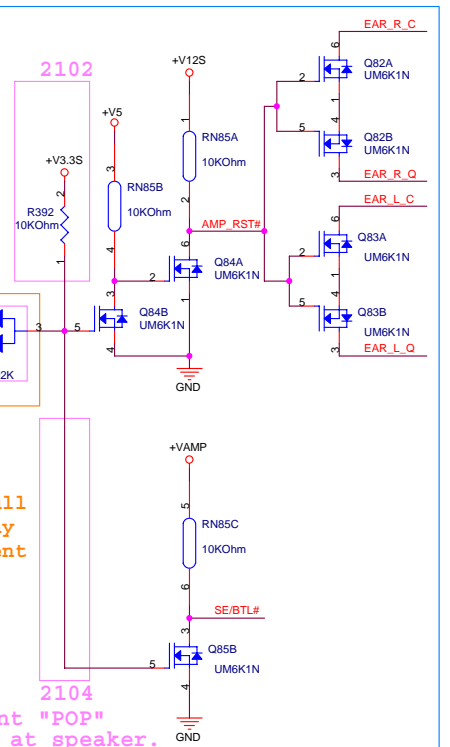
Pop noise can be heard via headphone when system boot, restart and resume from S3. Add OP_SD# to control the turn-on timing.

But when system resume from S3, pop noise is behind OP_SD# pull high. Add a delay circuit to prevent it.

Prevent "POP" noise at speaker.

BTL Gain=-2
R(FL) 10K
R(IL) 10K
=V
Speaker W=1W
Can use 1W(4ohm) speaker

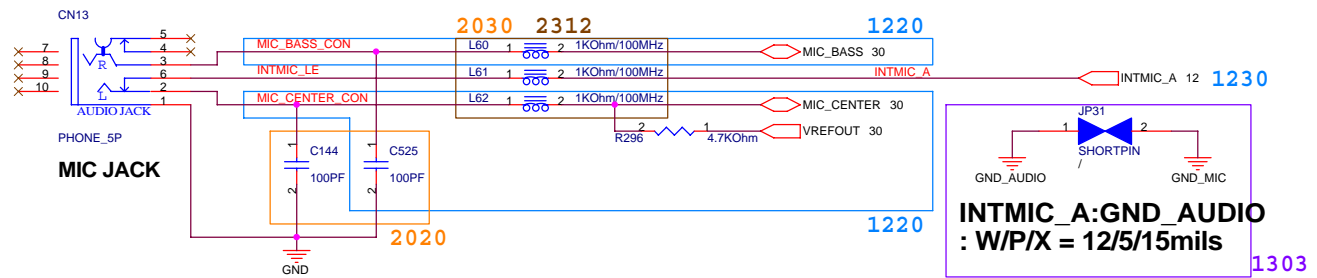
MIC OP CIRCUIT

MIC JACK

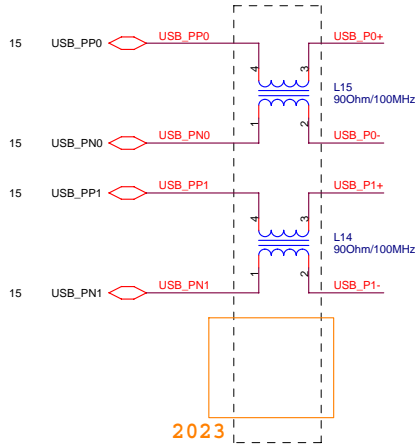
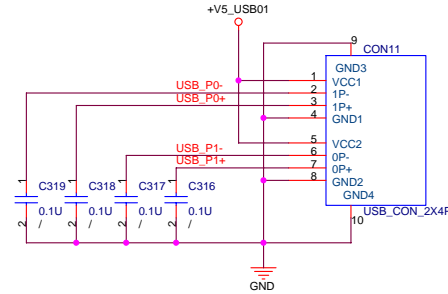
USB PORT 0 & PORT 1

VPLP R:2.2 use 07-014110900 (2nd source is 07-014110201)

R & L Co-Lay

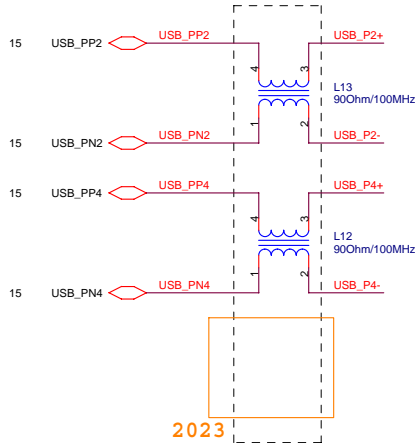
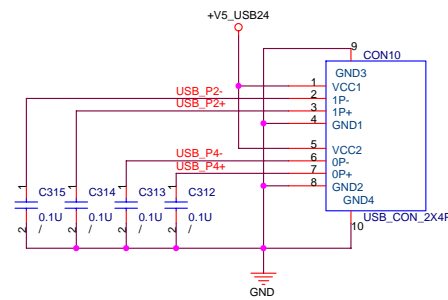
USB PORT 2 & PORT 4

VPLP R:2.2 use 07-014110900 (2nd source is 07-014110201)

R & L Co-Lay

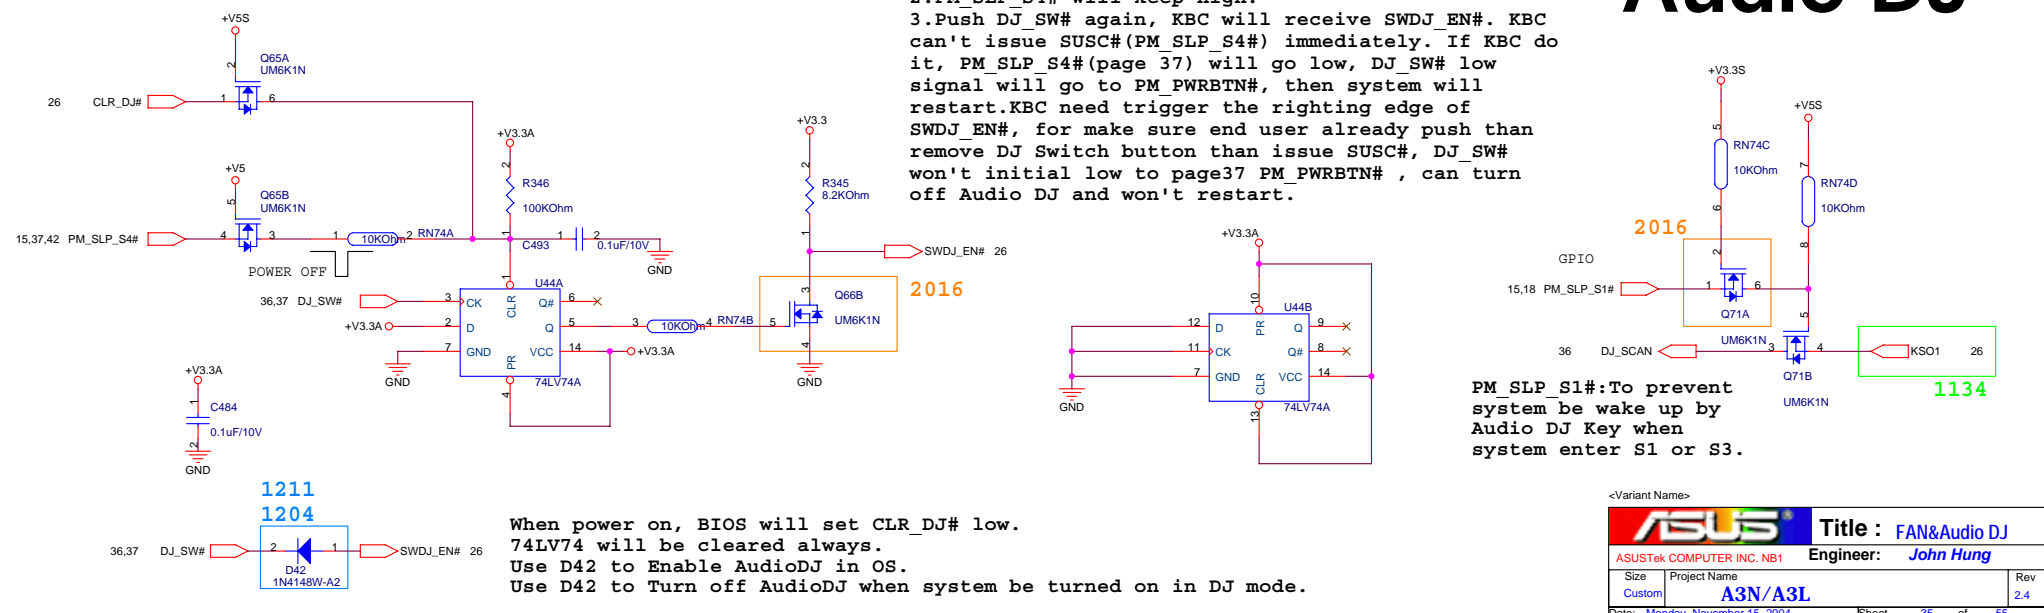
SWDJ_EN# function :

- 1.Push DJ_SW#, turn on Audio DJ.
- 2.PM_SLP_S4# will keep high.
- 3.Push DJ_SW# again, KBC will receive SWDJ_EN#. KBC can't issue SUSC#(PM_SLP_S4#) immediately. If KBC do it, PM_SLP_S4#(page 37) will go low, DJ_SW# low signal will go to PM_PWRBTN#, then system will restart.KBC need trigger the righting edge of SWDJ_EN#, for make sure end user already push than remove DJ Switch button than issue SUSC#, DJ_SW# won't initial low to page37 PM_PWRBTN# , can turn off Audio DJ and won't restart.

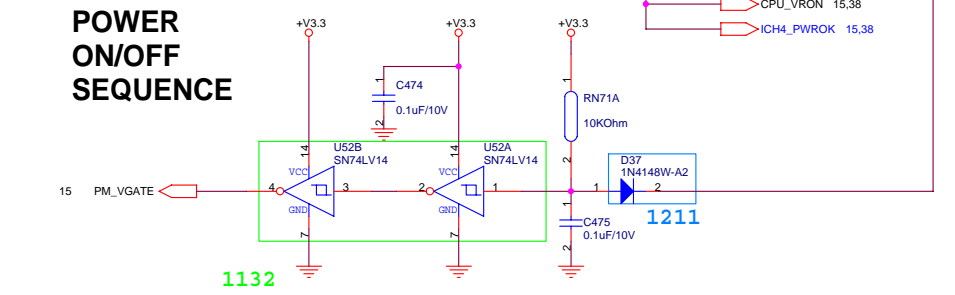
POWER ON/OFF SEQUENCE

System Power Sequence
 +VCCRTC -> RTCRST# -> V5REFSUS -> 3.3/1.8VSUS -> RSMRST# -> SLPS4# -> SLPS3# -> VCCLAN -> LANPWROK -> V5REF -> VCC -> VCORE -> PWROK -> VGATE
 SUSSTAT# -> PCIRST#
 CPU : +VCCORE, +VCCP, +V1.8S
 NB : +V1.2S, +V1.5S, +2.5V, +VCCP
 SB : +V1.5SUS, +V3.3SUS, +VCCP, +V1.5S, +V3.3S
 DDR : +V2.5, +V1.2S, +V1.25S

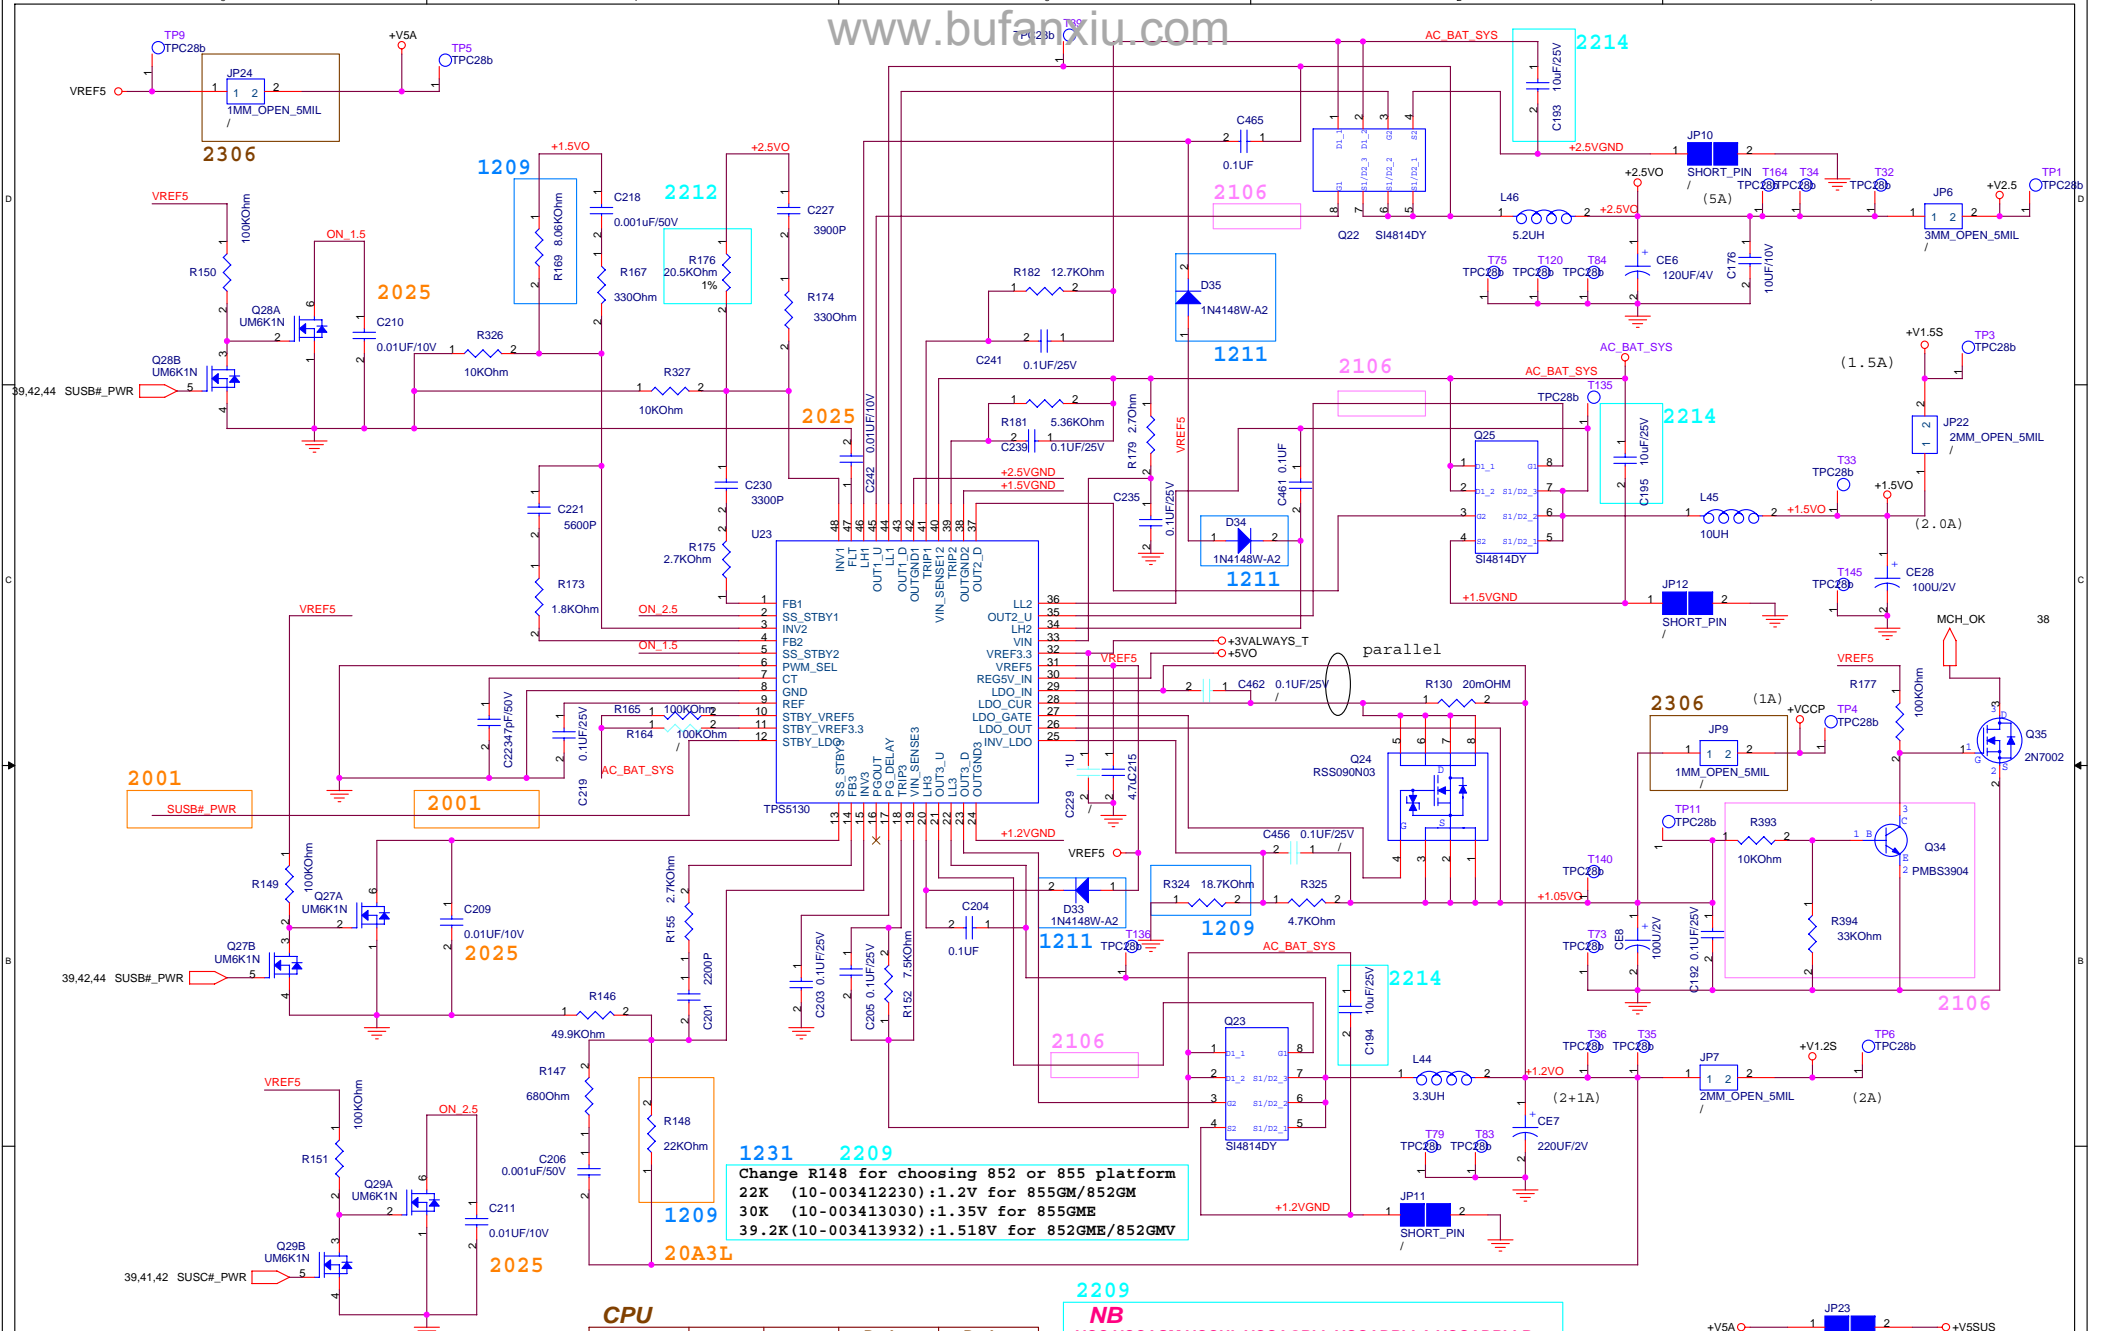
1231 2209
 Change R148 for choosing 852 or 855 platform
 22K (10-003412230): 1.2V for 855GM/852GM
 30K (10-003413030): 1.35V for 855GM
 39.2K (10-003413932): 1.518V for 852GME/852GMV

2209 NB
 VCC,VCCASM,VCCHL,VCCAGPLL,VCCADPLLA,VCCADPLLB:
 855GM/852GM: 1.2V
 855GME: 1.35V
 852GME/852GMV: 1.5V

Rev	Date	Description
R2.0 Orange Block	04/04/27	<p>20. EMI request, load C144, C525. page 32.</p> <p>21. ICH4 GPIO [24:43] , default state is output high, if PID_[0:3] be connected to GND by LCD cable, these GPIO will issue +V3.3(default output high) short to GND during system power on. Add R=2.2K to prevent this kind of situation. Page 15.</p> <p>22. Measurement team Problem: VGA EA fail below items 1,V-SYNC:under shoot over 30% of high level voltage range. 2,H-SYNC:over shoot over 30% of high level voltage range, under shoot over 30% of high level voltage range. Change Change C304, C305 from 5pF to 33pF. Page 13.</p> <p>23. EMI request use Choke on USB & 1394 ports. Delete option R, don't co-layout. Page 22,34.</p> <p>24. EMI request : Add C531,C532,C533,C535. Delete C147,C433. Change C110,C163 connection. Change C410 location. Change C378,C379,C410,C163,C110 to 0.1uF/10V. Change C471,C468 to 0.1uF/25V. Change C45,C33,C28,C134,C332,C399,C341 to 0.1uF/10V and don't load. Change C40 to 0.1uF/10V. Change C249 to 0.1uF/25V and don't load. Page 10,46. Change R104 from 0 ohm to bead. Page 31.</p> <p>25. Change C26,C98,C104,C325 (page3), C362 (page7), C324,C329 (page9), C436 (page14), C190,C441 (page16), C366,C367 (page19), C247 (page21), C467,C473,C478 (page22), C236 (page23), C209,C210,C211,C242 (page40), from 0.01uF/25V to 0.01uF/10V. Use 10V is OK.</p> <p>26. Measurement team Problem: VGA EA fail in rise time and fall time of RGB signal at resolution 1024X768 at 60Hz. Change L6,L7,L8 from 750hm/100MHz to 700hm/100MHz. Page 13.</p> <p>27. Load FAN on/off component : /FAN_SPD. page 35.</p> <p>28. Change L53,L54 from 09-012400000 to 09-012400001 for cost down. page38.</p> <p>29. CON1,CON7,CON12,CON15 and J4 change to formal P/N. page 12,24,25,36,44.</p> <p>30. For EMI RD's request, change R384 from 0 ohm to Ferrite bead, and add EMI capacitors: C28,C33,C45,C134,C167,C175,C332,C341,C399,C249. Page 32,46.</p> <p>A3L. For A3L platform : change U32 to 852GM, R148. page 6,7,8,9,40.</p>

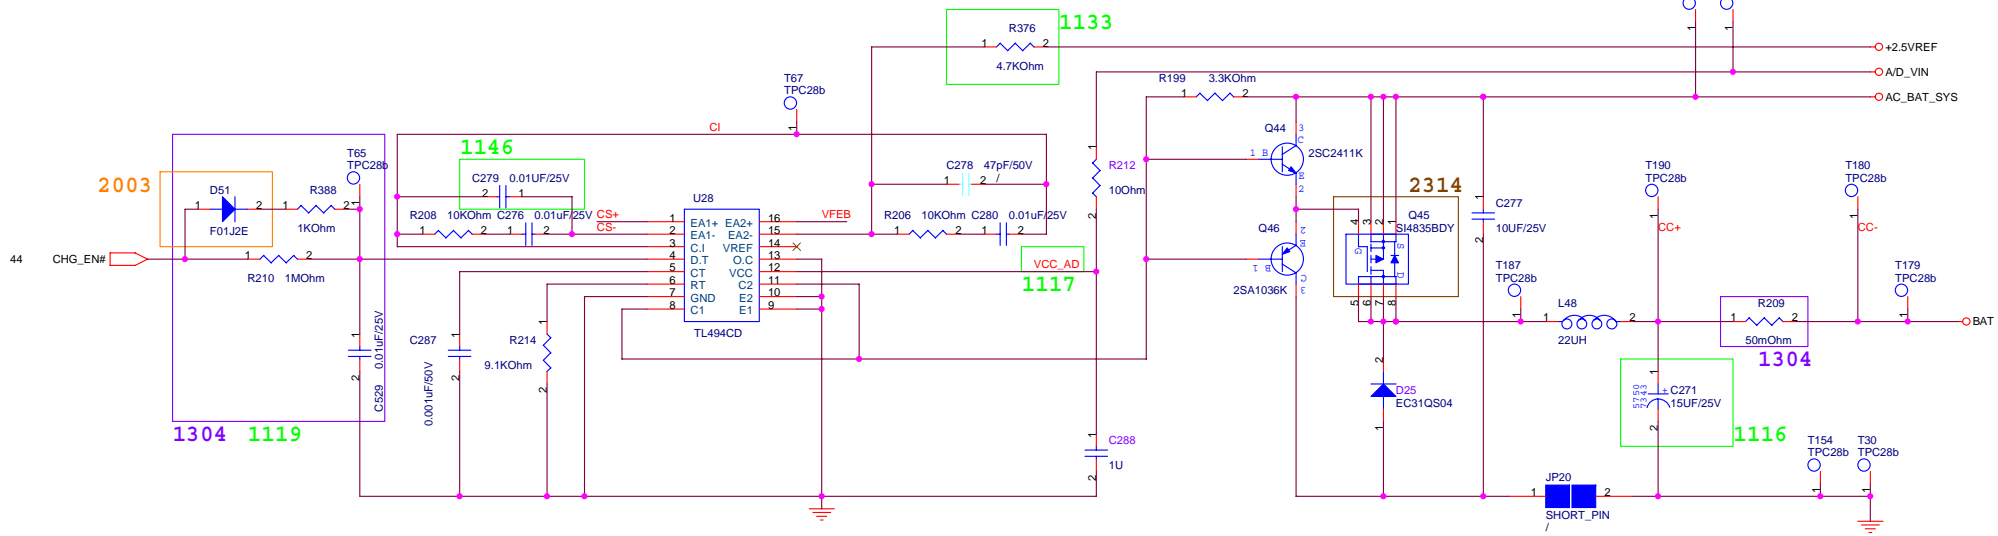
Current sharing = 3.1A

$A/D_VIN=19V$ $A/D_VIN_O=19V-3.1A*50\text{ohm}=18.845V$
 $CS+=CS-=19*(100/110)=17.272727V$
 $I1=(18.845V-17.272727V)/10K=0.15723mA$
 $V1=17.272727V-(0.15723mA*100K)=1.5497V$
 $I4=1.5497V/1K=1.5497mA$
 $I3=1.5497mA-0.15723mA=1.39247mA$
 $RC=(2.5V-1.5497V)/1.39247mA=681\text{ ohm}$

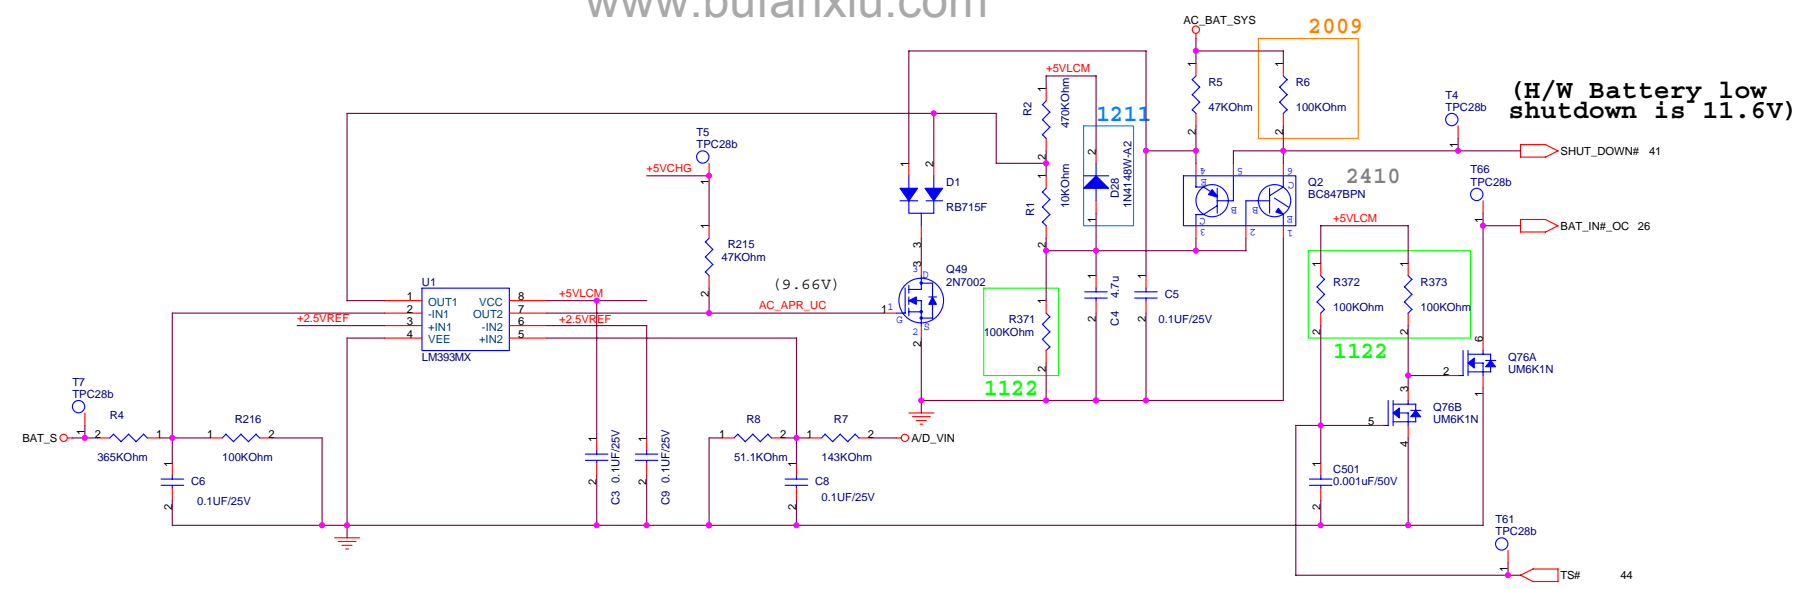
(H/W Battery low shutdown is 11.6V)

When system turn on by adapter power, " AC APR UC " will issue high, turn off Q41, to prevent AC power go into battery.
