A3 BLOCK DIAGRAM

North Bridge	DDR	CPU
A3N	855GM	266	Celeron/ Banias/ Dothan(400)
A3L	852GM	266	Celeron/ Banias/ Dothan(400)
A3Ne/A6Ne	855GME	333	Celeron/ Banias/ Dothan(400)
	852GME	333	Celeron/ Banias/ Dothan(400)/ Dothan(533)
A3Le	852GMV	266	Celeron/ Banias/ Dothan(400)/ Dothan(533)

FILE LIST

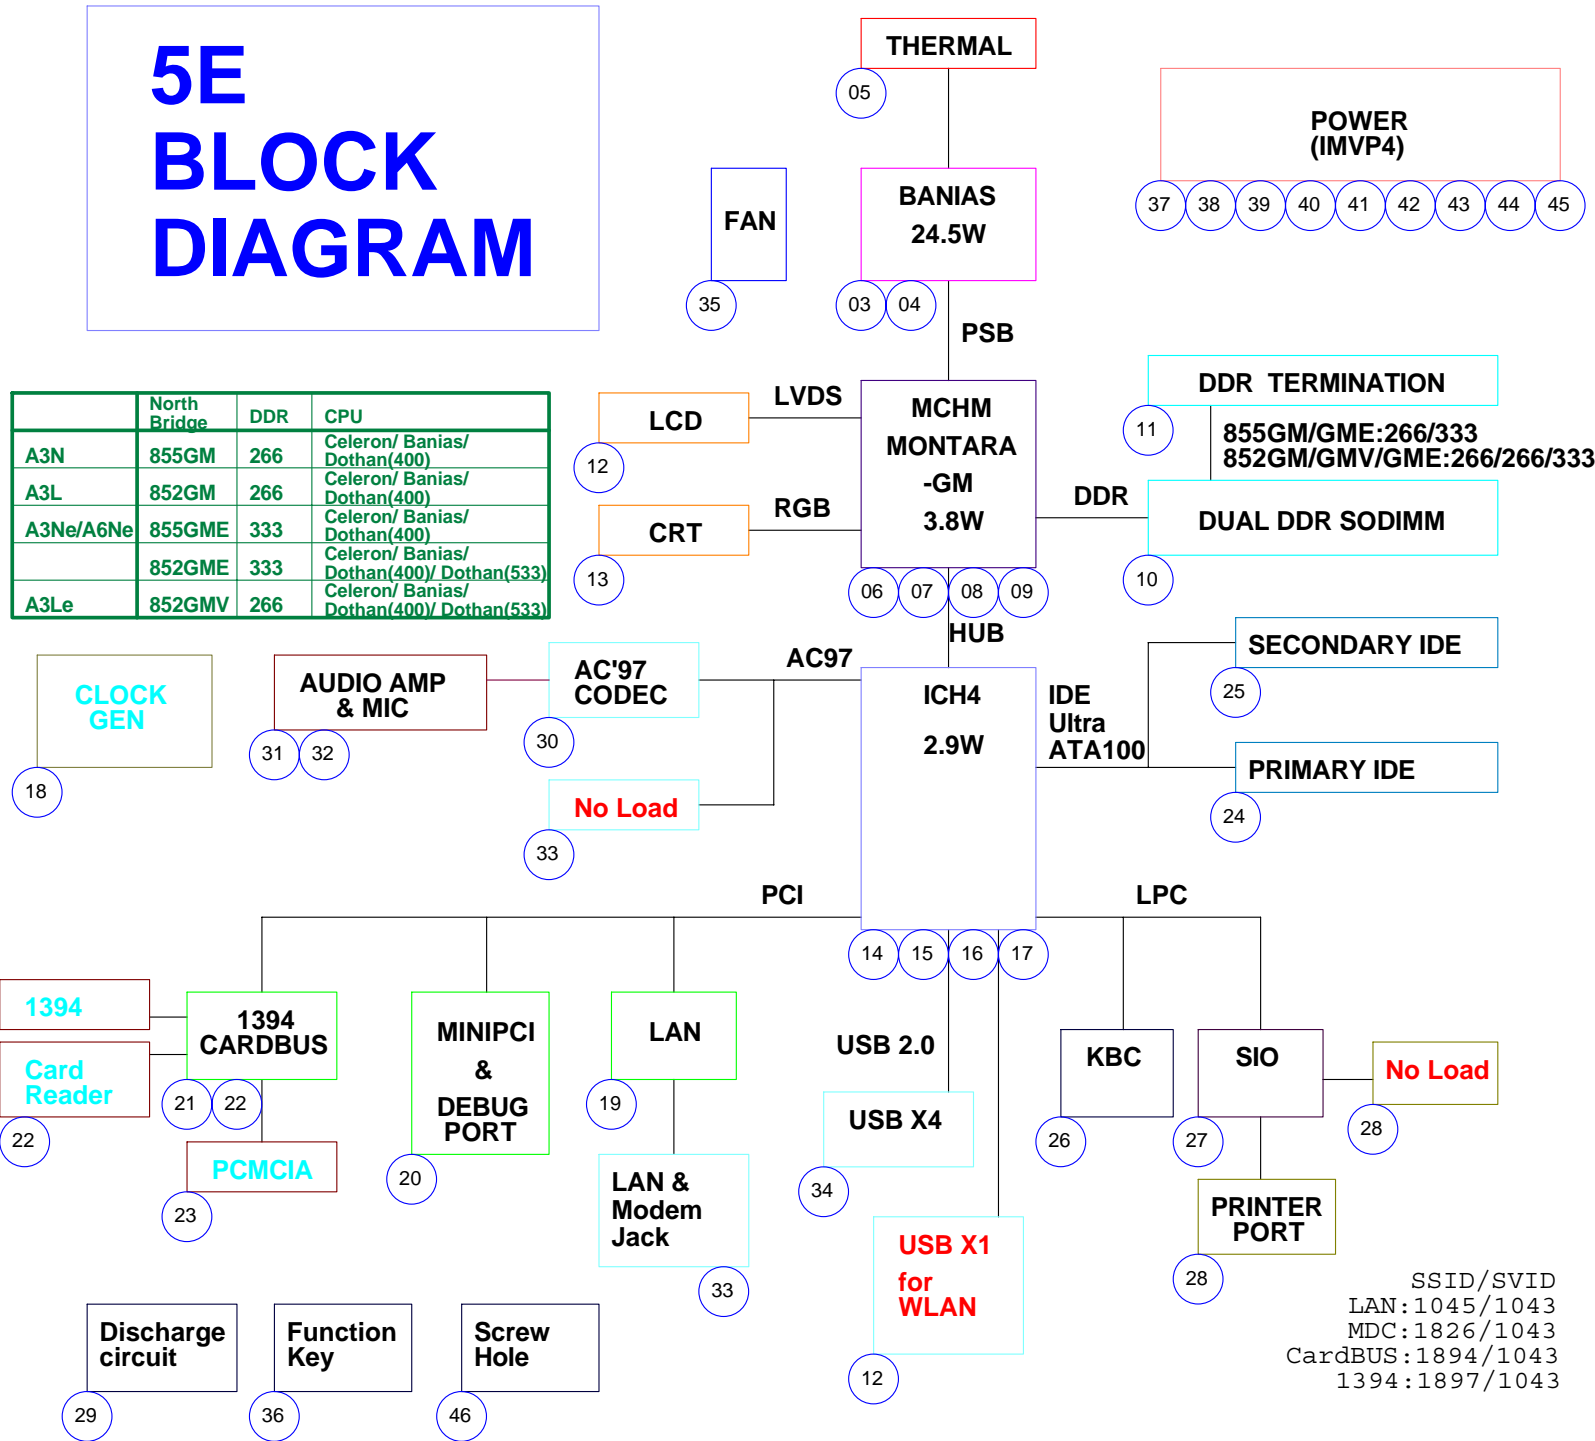
5E BLOCK DIAGRAM

North Bridge	DDR	CPU
A3N	855GM	266	Celeron/ Banias/ Dothan(400)
A3L	852GM	266	Celeron/ Banias/ Dothan(400)
A3Ne/A6Ne	855GME	333	Celeron/ Banias/ Dothan(400)
	852GME	333	Celeron/ Banias/ Dothan(400)/ Dothan(533)
A3Le	852GMV	266	Celeron/ Banias/ Dothan(400)/ Dothan(533)

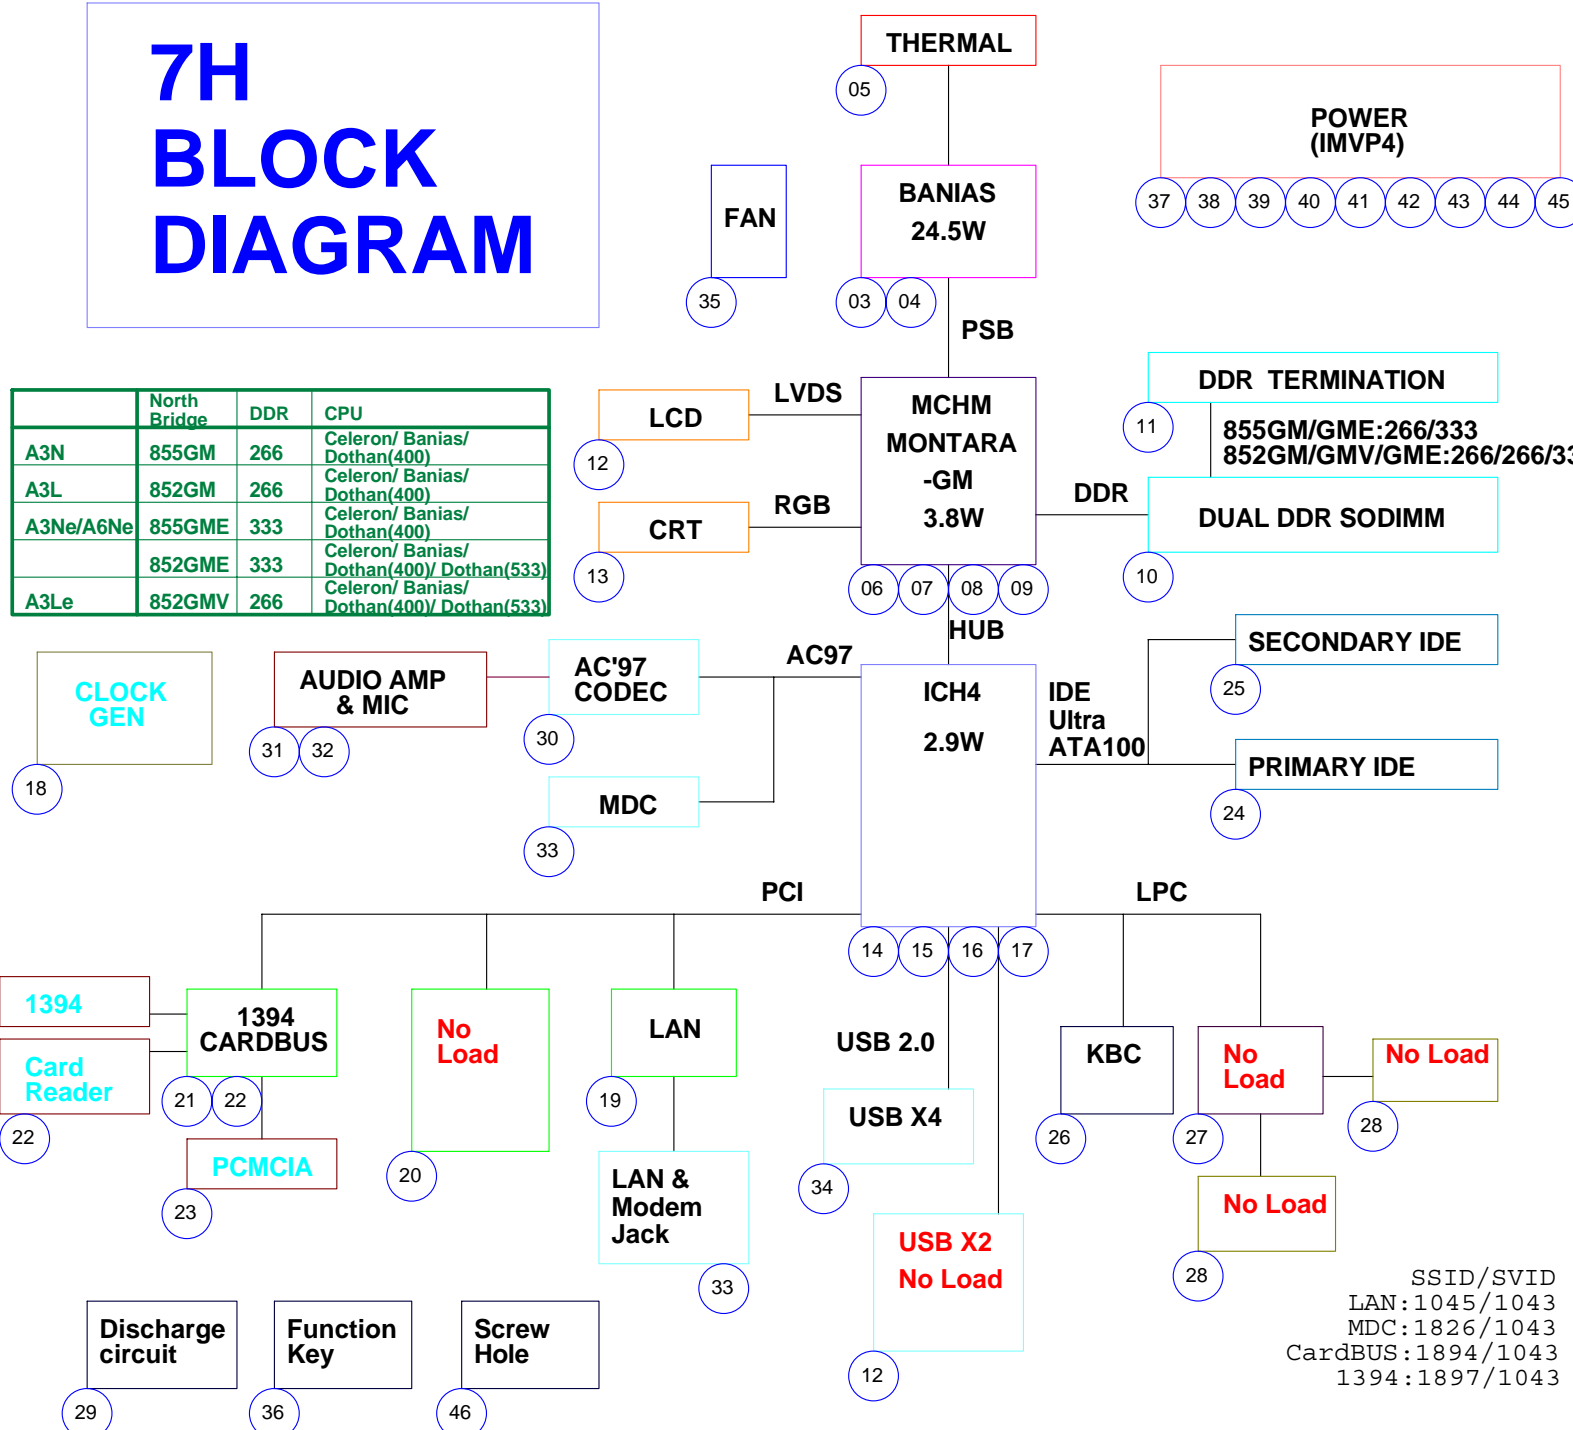
7H BLOCK DIAGRAM

North Bridge	DDR	CPU
A3N	855GM	266	Celeron/ Banias/ Dothan(400)
A3L	852GM	266	Celeron/ Banias/ Dothan(400)
A3Ne/A6Ne	855GME	333	Celeron/ Banias/ Dothan(400)
	852GME	333	Celeron/ Banias/ Dothan(400)/ Dothan(533)
A3Le	852GMV	266	Celeron/ Banias/ Dothan(400)/ Dothan(533)
